## Service Bulletin

SEB90-1  
Revision 3**TITLE**

MAIN LANDING GEAR PIVOT INSPECTION

**TITLE MAIN LANDING GEAR PIVOT AND ACTUATOR MODIFICATION**

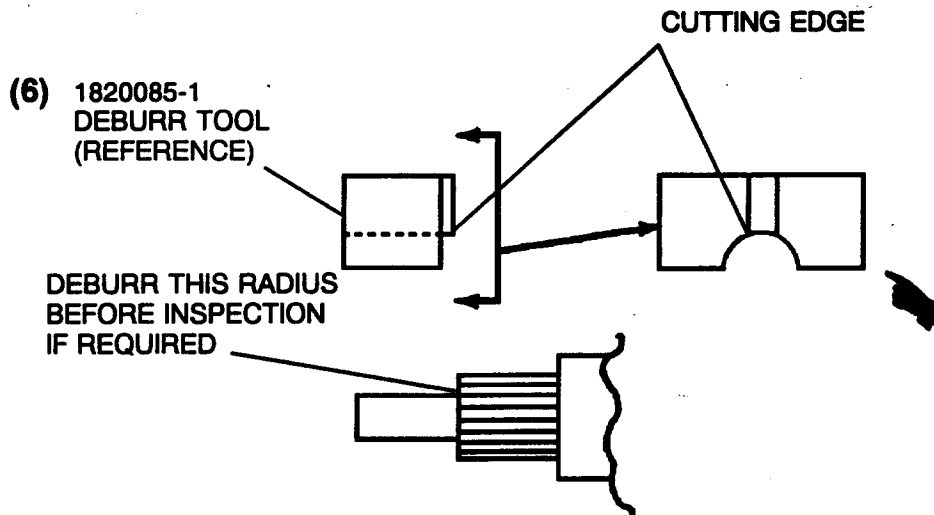
## DETAIL B

PIVOT ASSEMBLY SHAFT AND  
SPLINE WITH BUSHING REMOVED

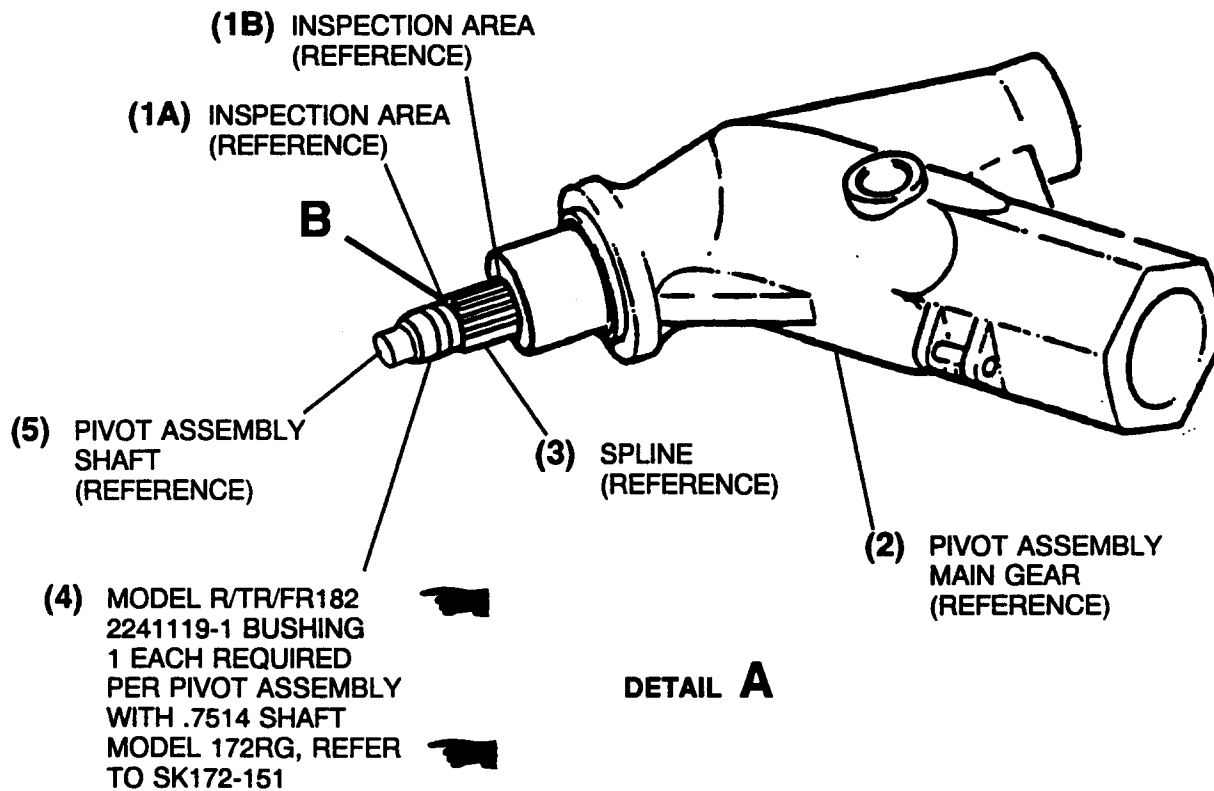
## DETAIL A

5. Remove bushing (4) from pivot assembly shaft. Use a vise-grip type pliers or suitable tool to remove press fit bushing. Removal of bushing is required to inspect area (1A) between bushing (4) and spline (3). Discard bushing.
6. (Refer to Figure 1, Detail A, Sheet 2.) Perform a fluorescent penetrant inspection in areas (1A & 1B) on each pivot assembly as follows:
  - a. Using a magnifying glass inspect the radius of area (1A) for burrs that may be present as a result of the press fit bearing installation. If the inspection reveals the presence of a burr, continue with Step b. If the radius is free of burrs, continue with Step c.

**CAUTION:** SANDING OR FILING ON SHAFT OR IN SHAFT RADIUS IS NOT ALLOWED. SANDING OR FILING WILL CAUSE PARTS TO BE UNDERSIZE AND REQUIRE REPLACEMENT. ONLY THE DEBURR TOOL IS ALLOWED TO BE USED FOR BURR REMOVAL.
  - b. Using part number 1820085-1 Deburr Tool (6), remove the burr in the radius of area (1A). Place tool on pivot shaft per Detail B and rotate completely around shaft to shave off burr.
  - c. Clean each pivot assembly (2) in inspection areas (1A & 1B) with ZC-7 Cleaner using a lint free cloth.
  - d. Apply ZL-22 Penetrant to the areas previously cleaned in Step c. and allow penetrant to remain on these areas for thirty minutes.
  - e. Clean the penetrant from the pivot assemblies using a clean lint free cloth dampened with ZC-7 cleaner. The inspection area is considered clean with a absence of background fluorescences.
