[Docket No. 2001-SW-13-AD; Amendment 39-12408; AD 2001-17-17]

Airworthiness Directives; Bell Helicopter Textron, Inc. Model 47B, 47B-3, 47D, 47D-1, 47G, 47G-2, 47G2A, 47G-2A-1, 47G-3, 47G-3B, 47G-3B-1, 47G-3B-2, 47G-3B-2A, 47G-4, 47G-4A, 47G-5, 47G-5A, 47H-1, 47J, 47J-2, 47J-2A, and 47K Helicopters

ACTION: Final rule.

2001-17-17 Bell Helicopter Textron, Inc.:
Amendment 39-12408. Docket No. 2001-SW-13-AD. Supersedes AD 2000-18-51, Amendment 39-11983, Docket No. 2000-SW-35-AD.

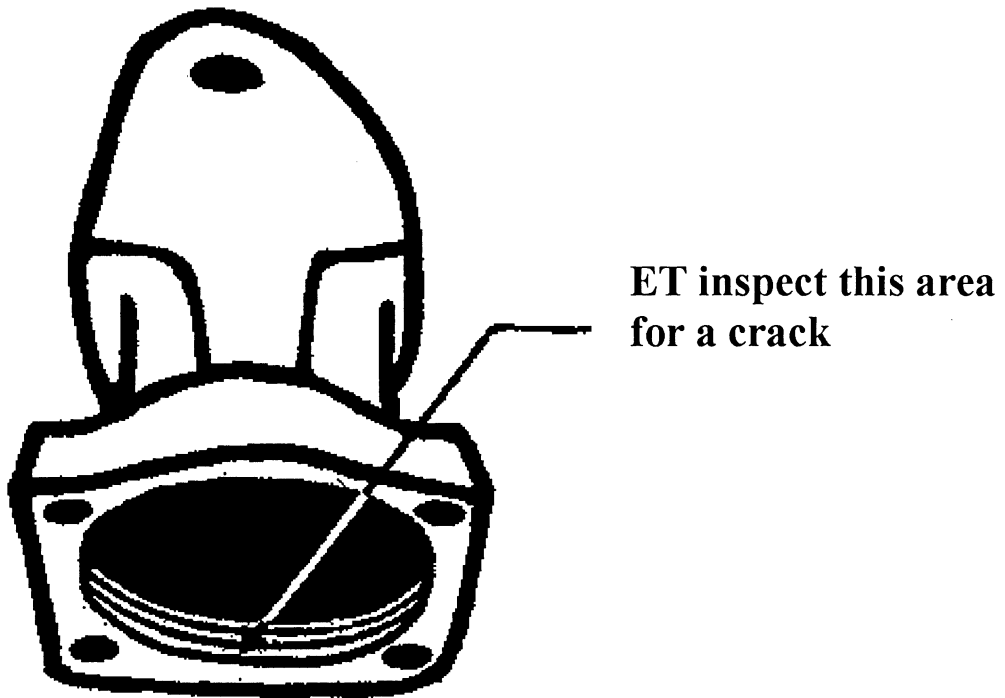
Figure 1, Appendix 1

1.1 The inboard inside diameter machined threads (reference figure 1).

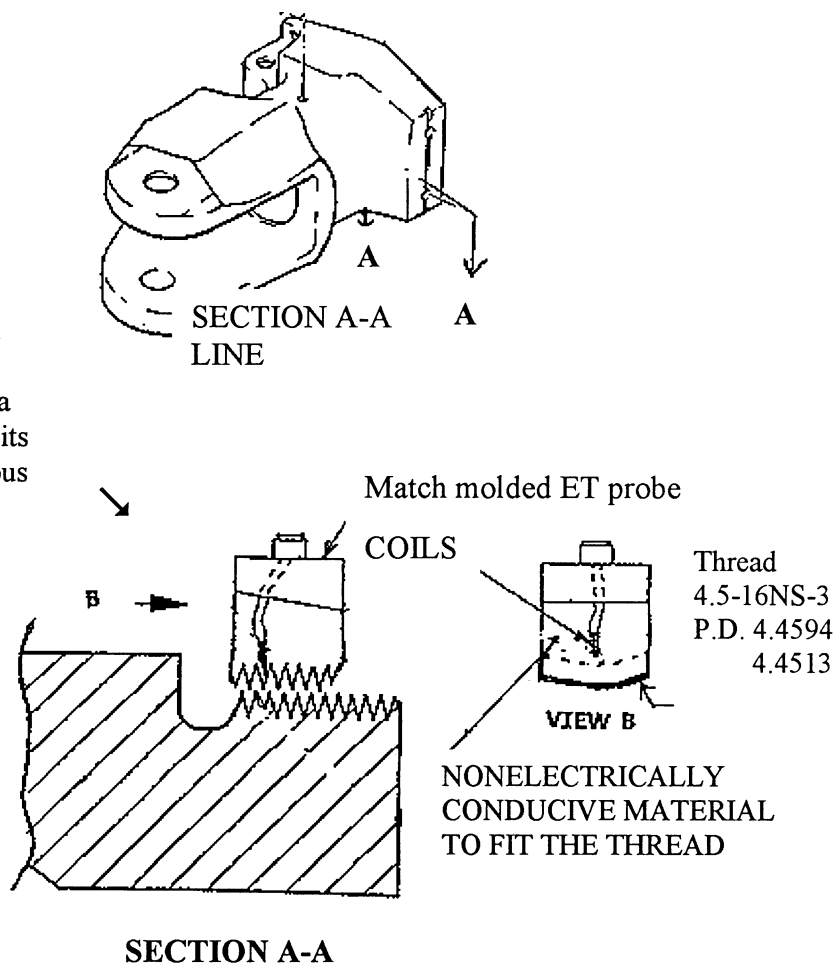
Figure 3, Appendix 1

2.2 Match molded ET probe SPC-193 (100kHz) or equivalent. (See Figure 3.)

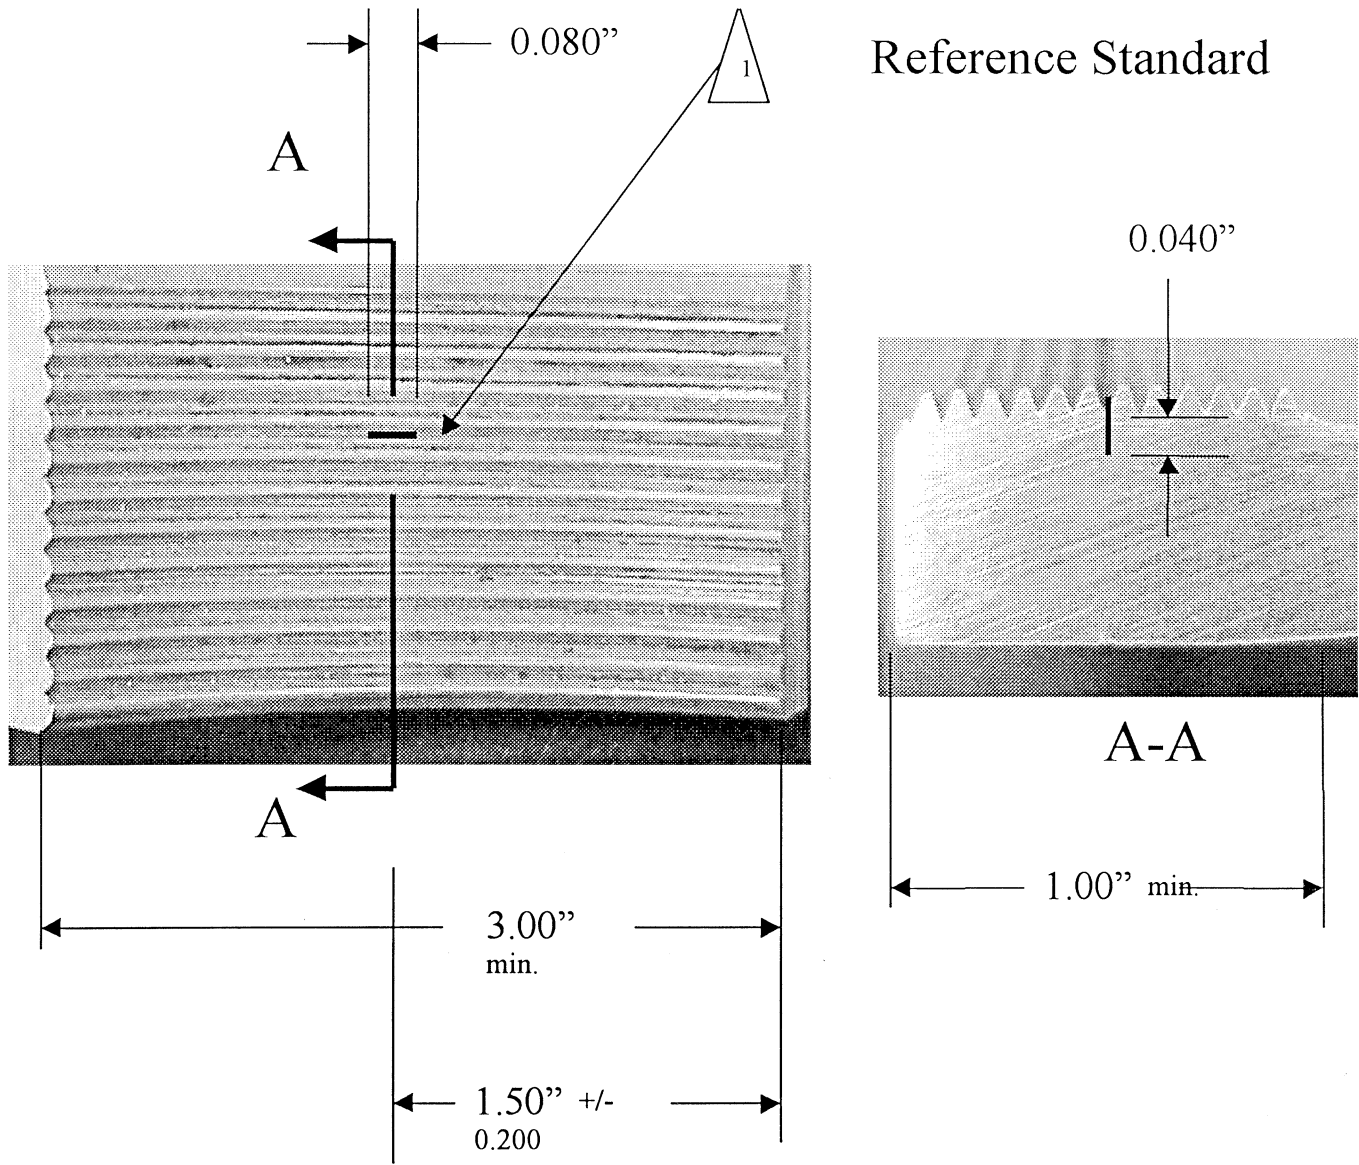
Figure 4, Appendix 1

2.3 Reference standard EC-010-021, or equivalent. (See Figures 4 and 5.)

EDM 1 place only in thread root.
Notch width shall be 0.004 max.
All other dimensions to be +/- 0.004 from indicated.
