SUMMARY: This amendment supersedes Airworthiness Directive (AD) 75-23-08 R5, which currently requires repetitively inspecting and replacing or repairing the exhaust system on certain Cessna Aircraft Company (Cessna) 300 and 400 series airplanes. The requirements of this AD replace the inspections and replacements that are required by AD 75-23-08 R5 with inspections and replacements containing new simplified procedures for all 300 and 400 series airplanes (models affected by the current AD plus additional models). This AD also revises the inspection intervals and requires replacing certain unserviceable parts and removing the exhaust system for a detailed inspection. This AD is the result of numerous incidents and accidents relating to the exhaust systems on Cessna 300 and 400 series airplanes dating from the middle 1970's to the present, including six incidents since issuance of AD 75-23-08 R5 where exhaust problems were cited. The actions specified by this AD are intended to detect and correct cracks and corrosion in the exhaust system, which could result in exhaust system failure and a possible uncontrollable in-flight fire with pilot and/or passenger injury.

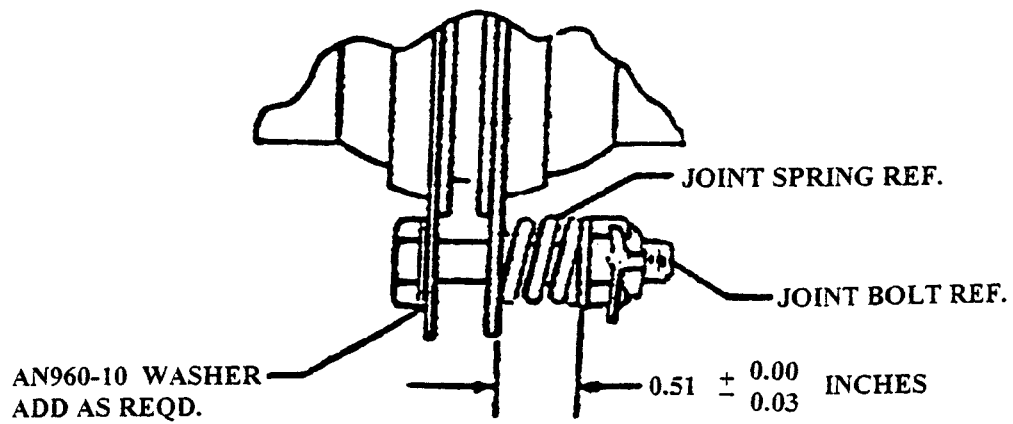
FIGURE 1 to the Appendix

Typical Exhaust Joint Spring Installation

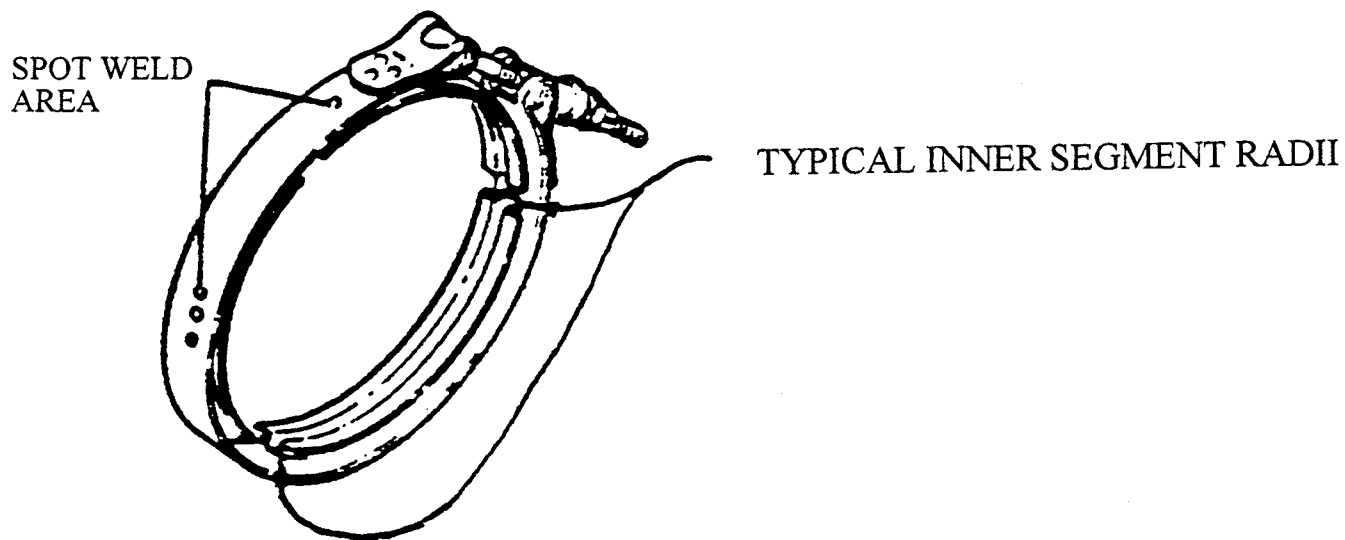
FIGURE 3 to the Appendix

Multi-Segment "V" Band Clamp

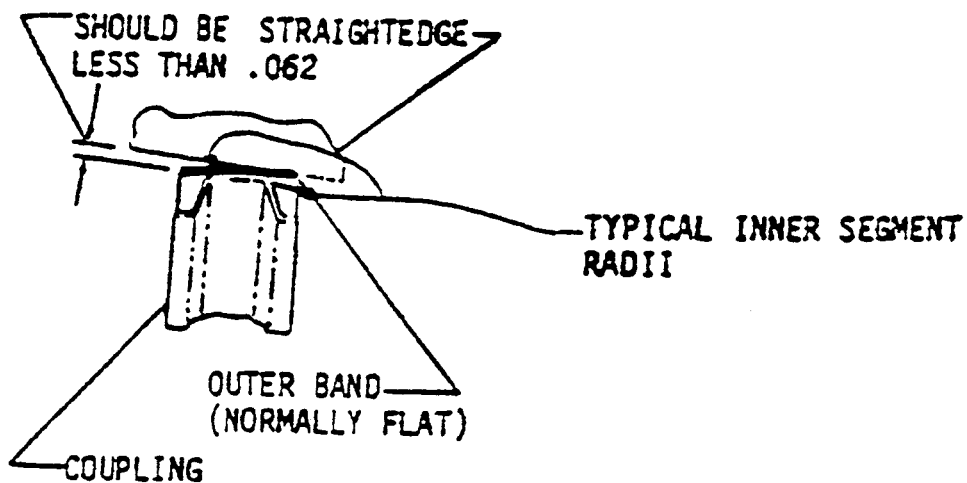
FIGURE 4 to the Appendix

Multi-Segment "V" Band Clamp Outer Band Flatness Check

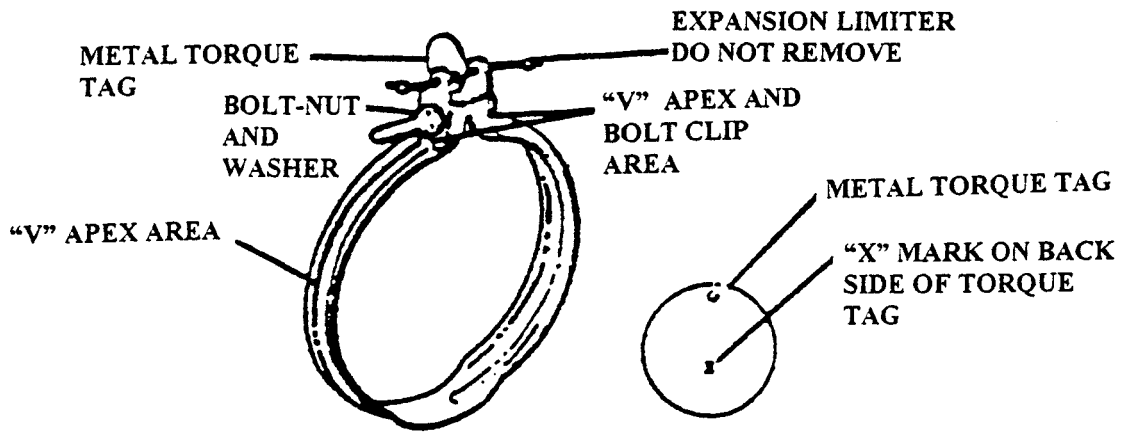
**One-Piece "V" Band Type Clamp****FIGURE 5 to the Appendix***Inspection of the Exhaust System Aft of the Slip Joints*

(iv) Visually inspect the one-piece "V" band clamp (overboard exhaust to turbocharger) with a light and mirror, in the area of the clamp surfaces adjacent to the intersection of the "V" apex and bolt clips, and the entire length of the "V" apex of the clamp for signs of cracks or fractures. If cracks or fractures are visible, replace the clamp (see Figure 5 of this Appendix). See Cessna service manual(s) and revisions for correct installation procedures
