SERVICE BULLETIN

TITLE: WINGS - INSPECTION OF WING SPAR STRUCTURE

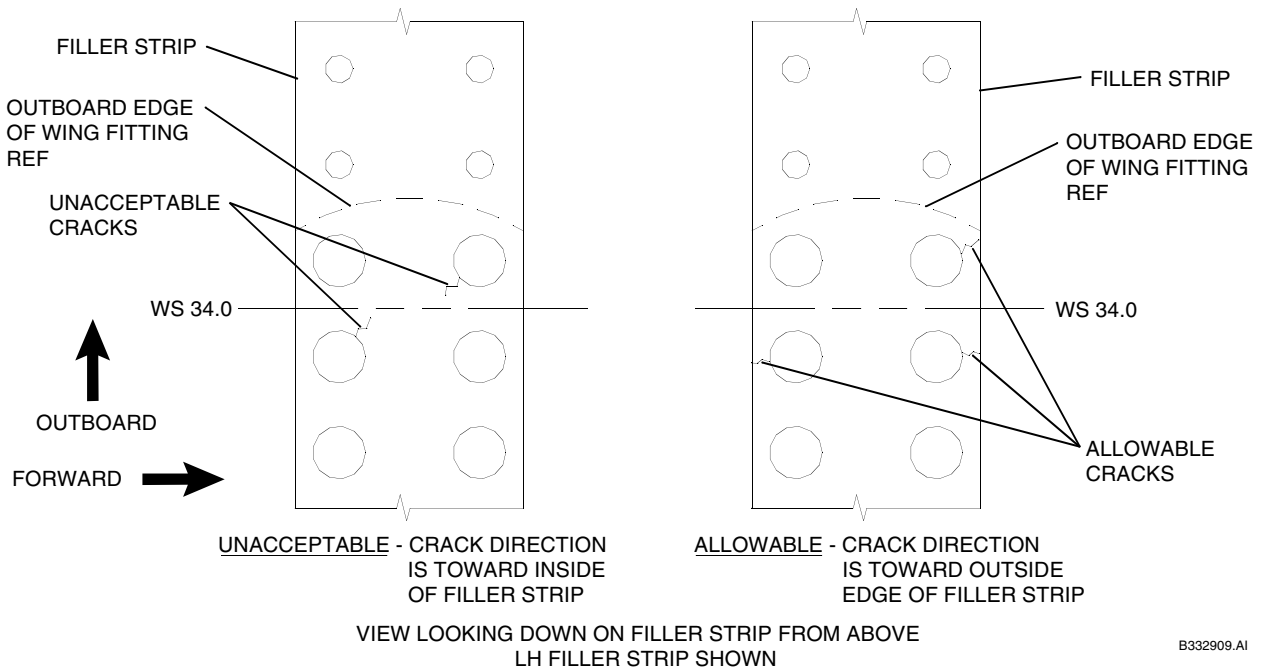
Filler Strip Cracks
Figure 10

A crack indication in the filler strip may be allowed, but only if the direction of the crack indication is toward the outside edge of the filler strip. If the direction of the crack indication is toward the inside of the filler strip, the spar assembly must be replaced. Reference Figure 10.

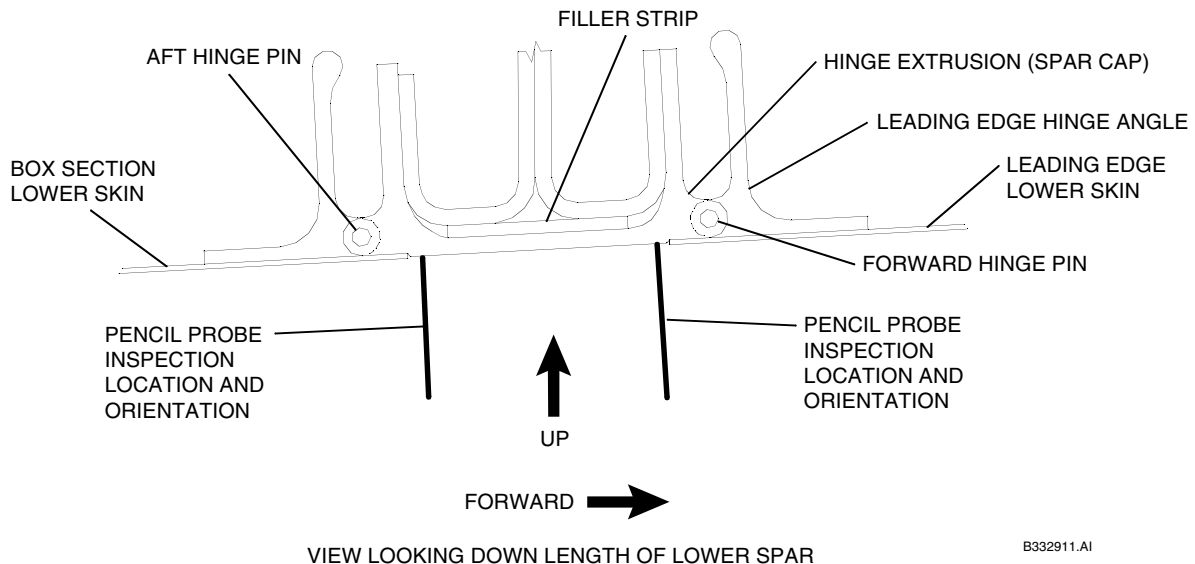
Eddy Current Inspection of Forward Spar (Lower Surface)
Figure 12

- Instrument: Same as used to inspect the inboard area of the forward wing spar in step (8) (d).
 - Shielded Eddy Current pencil probe, minimum 100 kHz, absolute coil.
 - Aluminum Electron Discharge Machining (EDM) notch standard as shown in Figure 9.
- (i) Adjust the instrument using the .030" EDM notch on the flat of the standard. Obtain a minimum 50% screen deflection.
- (ii) On the lower surface of the forward spar from the attach fitting outboard to the end of the exposed spar (wingtip), scan the exposed surface of the forward and aft edges of the hinge extrusion adjacent to the hinge attach point with the pencil probe as shown in Figure 12.

- (f) If a crack is found during the Eddy Current Inspection of the forward spar as outlined in step (d) and step (e), the entire forward (main) spar assembly must be replaced **BEFORE FURTHER FLIGHT**.
- (9) Inspect three (3) MLG trunnion fitting fastener locations as follows:
- (a) Locate the MLG trunnion fittings in the wheel well area, reference Figures 3, 13, 14 and 15. The forward trunnion fitting is attached to the aft side of the forward (main) spar and the aft trunnion fitting is attached to the forward side of the aft (rear) spar near W.S. 63.0.
