The National FAA Safety Team Presents

Topic of the Month
September, 2024

GA Aircraft Exhaust Systems

Produced by:
The National FAA Safety Team (FAASTeam)

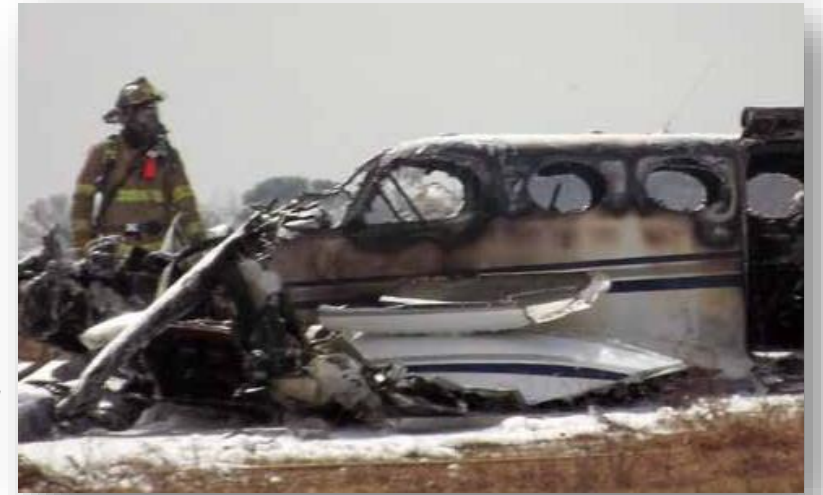
NTSB probable cause: The fatigue failure of the turbocharger exhaust band clamp.

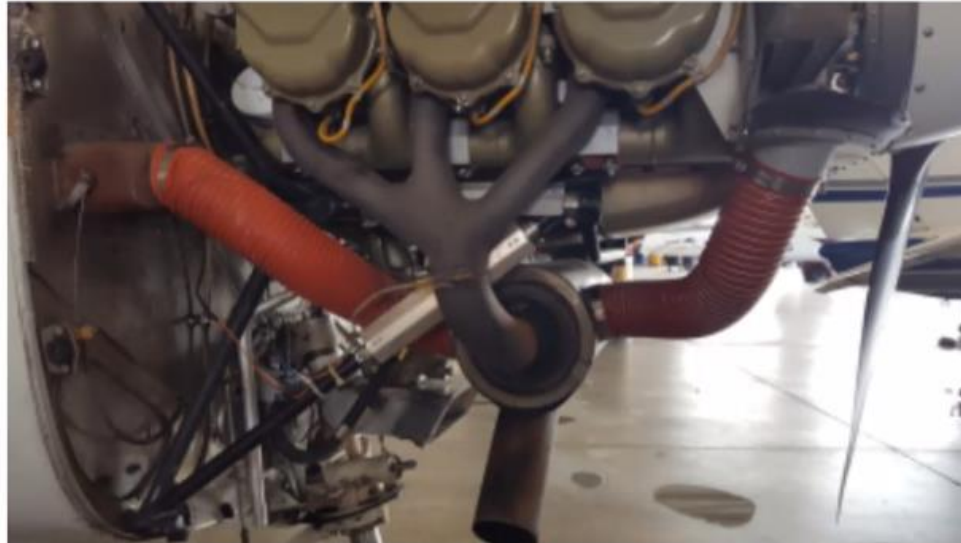
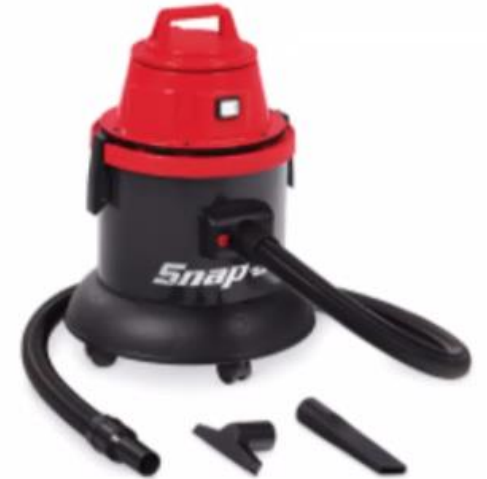
Simple Pressure Test!

- Some testing can be done with a vacuum.
- AC 91-59A has information about performing this inspection.

- Use the “blow” side of the shop vac
- Use soapy water to check for leaks

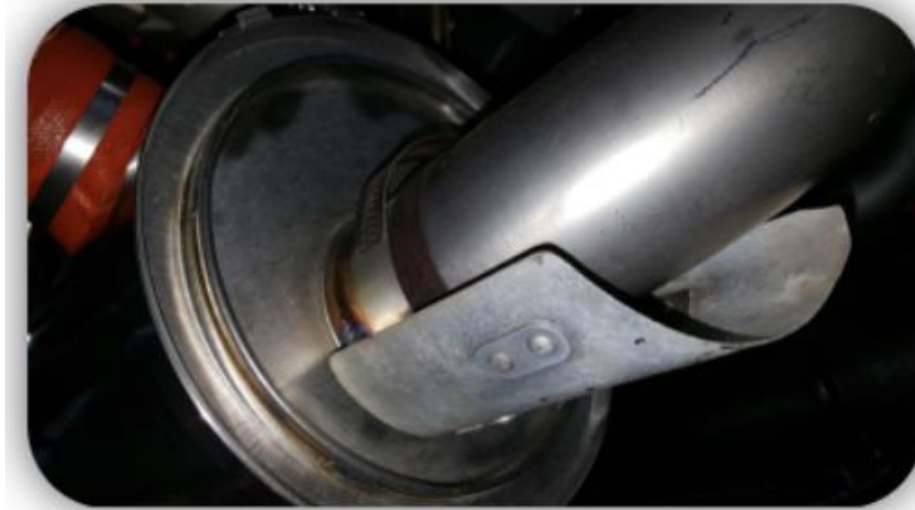
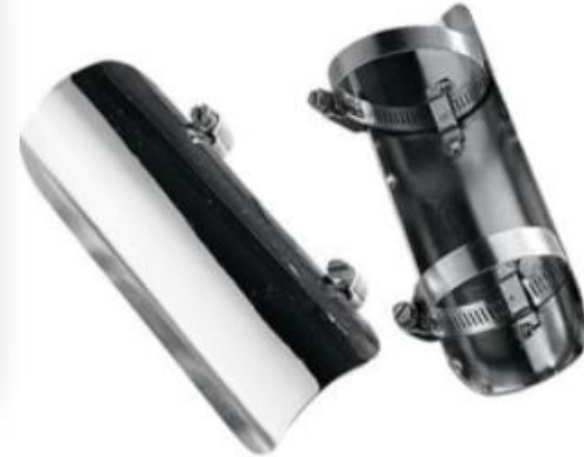
- **Check correct placement and condition of heat shields**

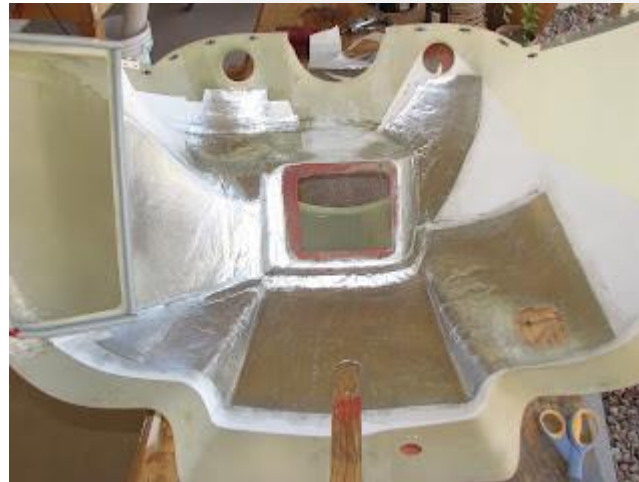
- **Condition of heat shield foils**

- RV-12 fiberglass bottom cowl

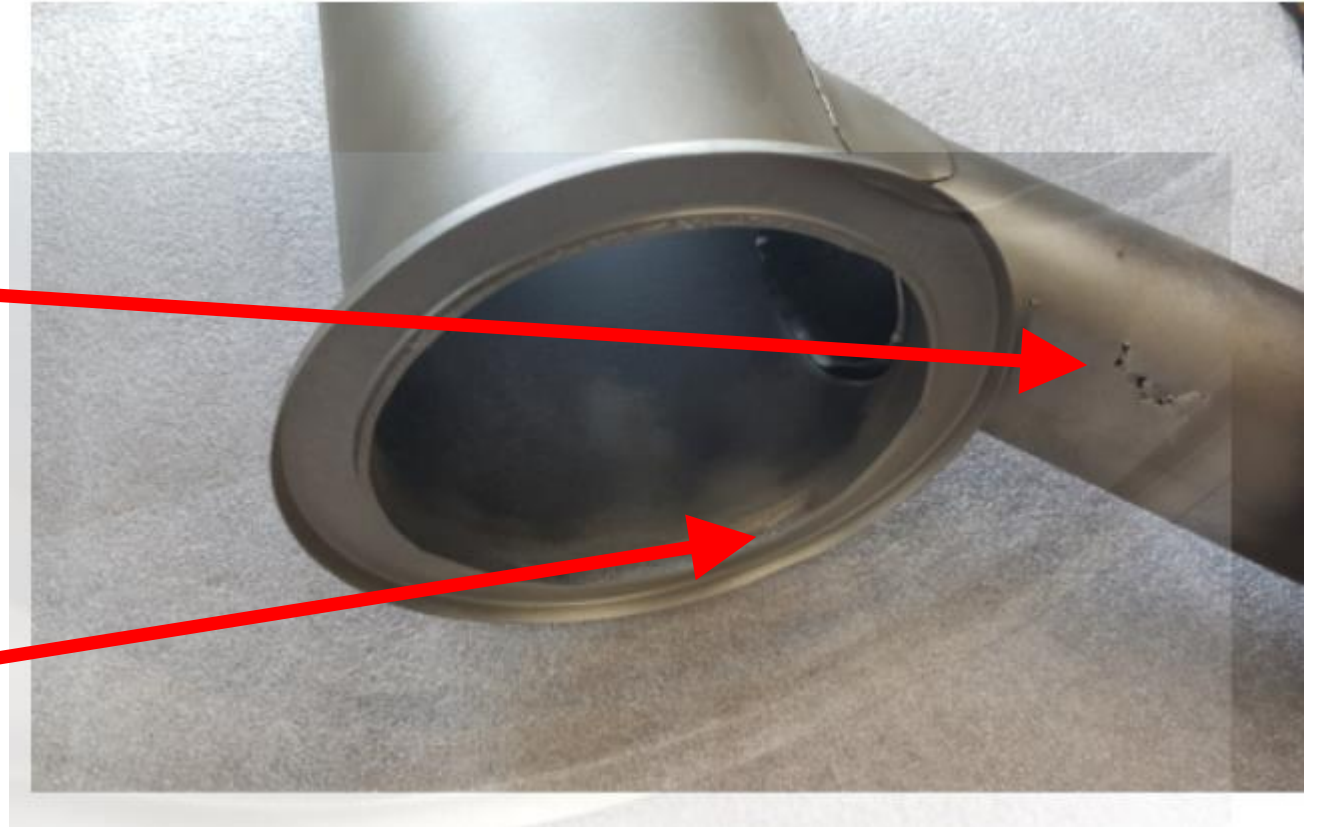
Looks Corroded? (Then probably is...)

- **Bead blasting reveals pin holes from corrosion**

- **Also, flange issue**

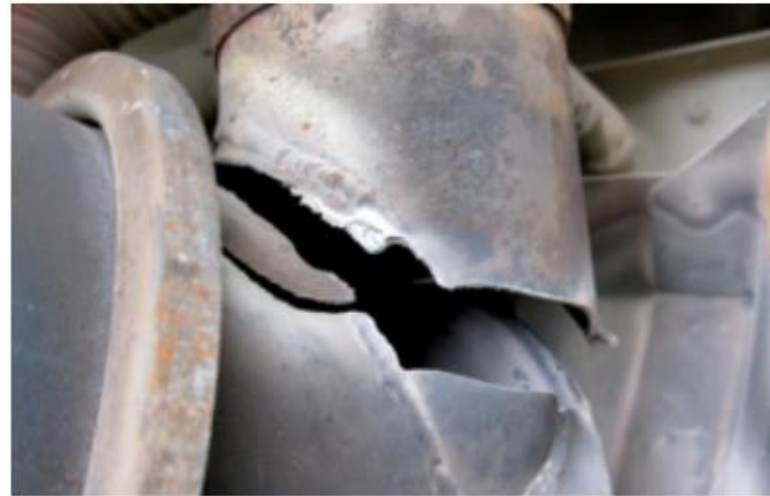
Exhaust Manifold and Stacks/Pipes

- Exhaust manifold and stack failures are usually fatigue related at welded or clamped points
- These failures are fire hazards as well as the possibility of CO poisoning

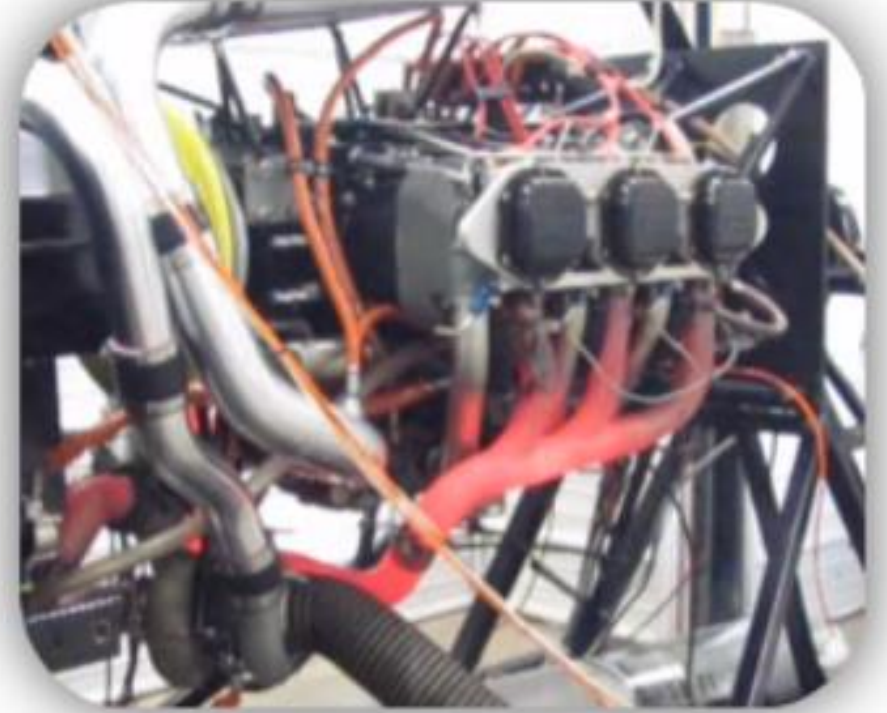
Exhaust Blow Torch:

- **High pressures**
- **High temperatures**
- **At high altitudes, turbo working really hard maintaining sea level pressure**
- **Due to pressure differentials, leaks can result in a blow torch-like blast**
- **Melts things**
- **Fire hazard**

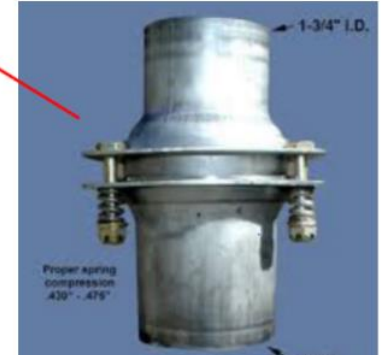
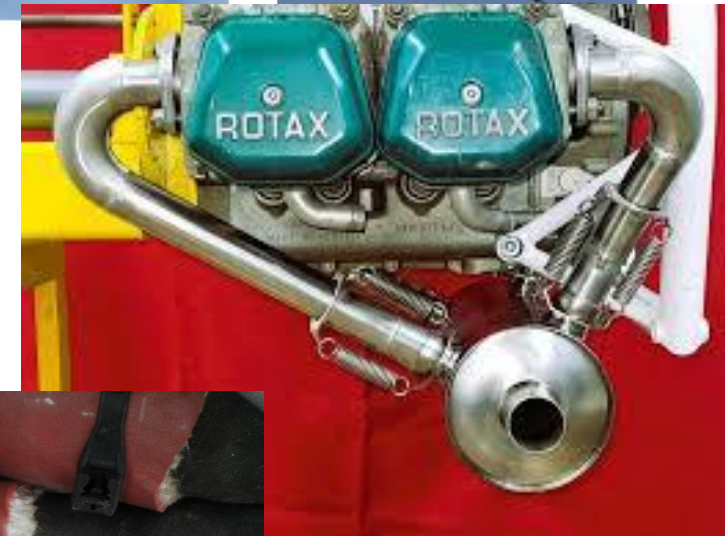
Joints and Flanges:

- Special attention areas
- Look for signs of leakage
- Check integrity of clamps and springs
- Springs loose or broken
 - Springs allow for movement and expansion
- Follow manufacturer's procedures:
 - Anti-seize paste on ball joints to maintain joint flexibility
 - Safety wire retaining springs
 - RTV in/on springs for dampening

• Ball Joints

• Slip Joints

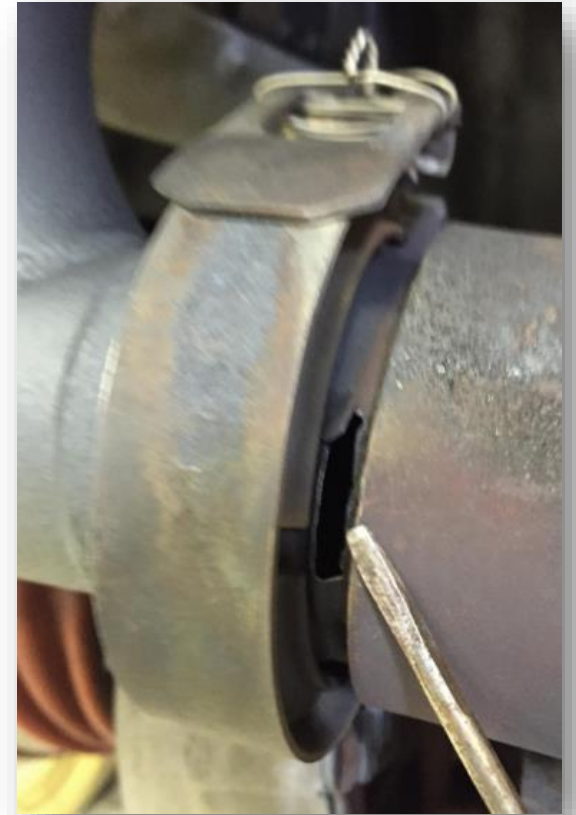
Exhaust Components

- Exhaust system components require special attention
- Might hide under clamps
- Look for streaks, discoloration...

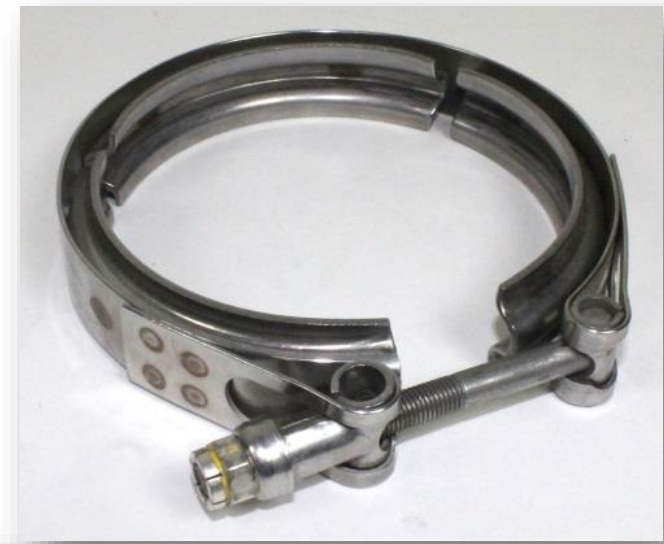
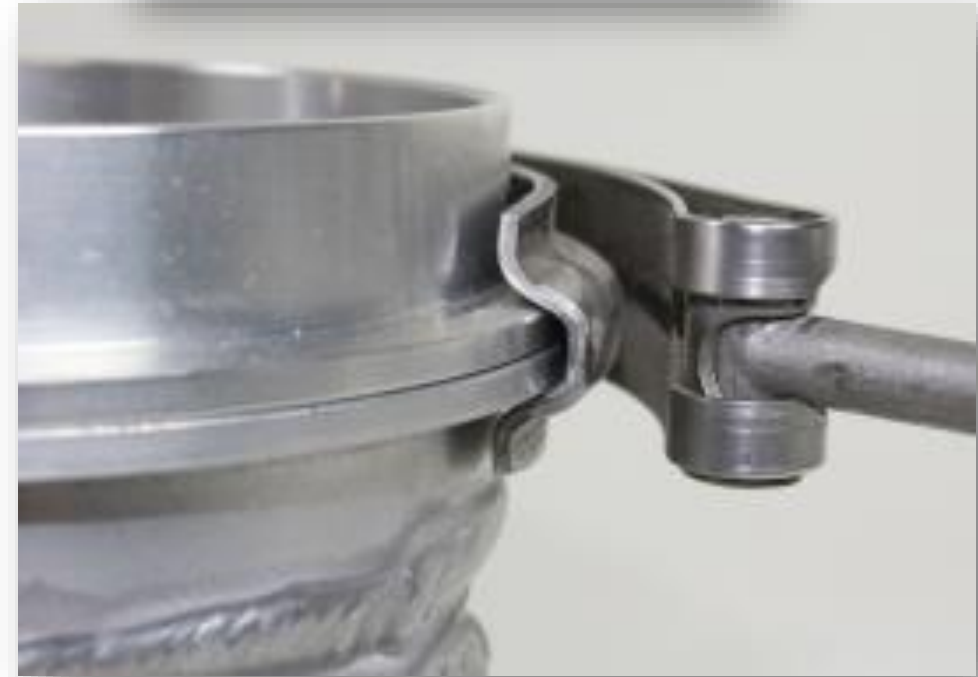
V-Bands

- V-band clamps are the preferred connection for many exhaust or intake systems
- A V-band applies uniform and equal closing force around the entire circumference of the flange
- Once tightened, friction between the flanges and V-retainer reduce the load on the bolt and clamp
- **BUT, they can and do fail...**

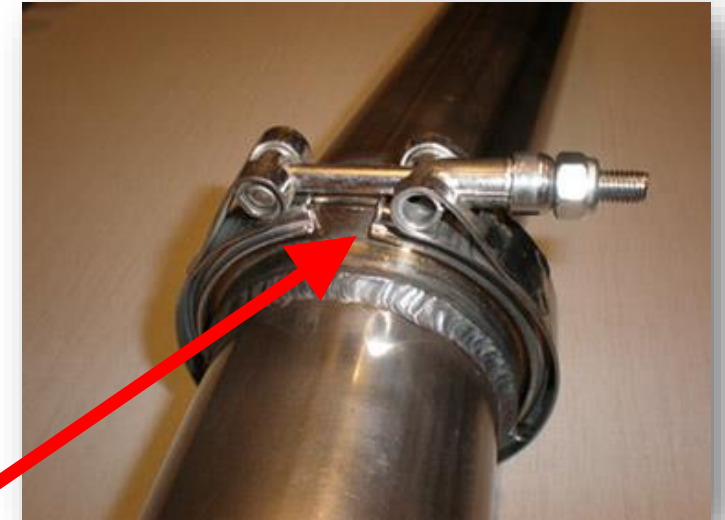
V-Band Cautions

- **Tubes and components of the coupling must be aligned before installing the coupling**
- **The flanges must be aligned correctly to prevent failures**
- **Ensure that the V-band does not bottom out on the flange before reaching the required torque**

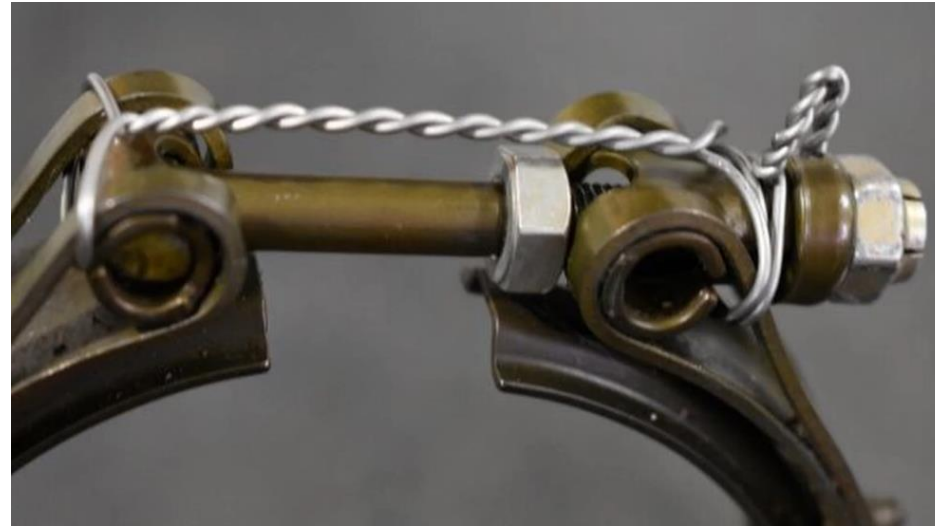
V-Band Cautions

- **Safety wire needed as directed**
- **Clamp held by safety wire if T-bolt fails**

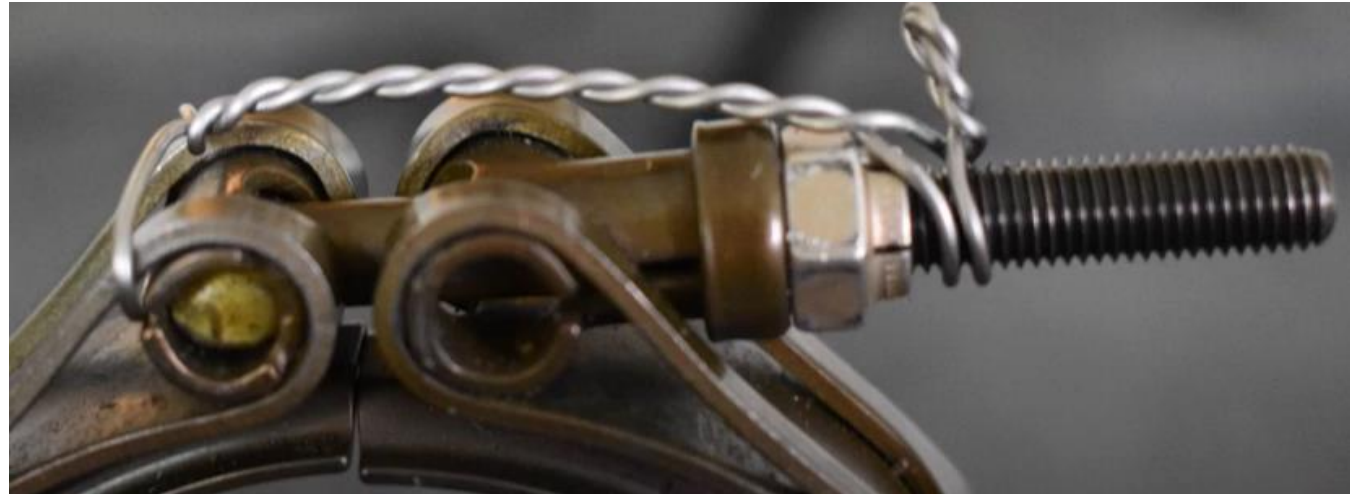
V-Band Cautions

- **Wrong...**
- **If T-bolt fails it will still fall apart**

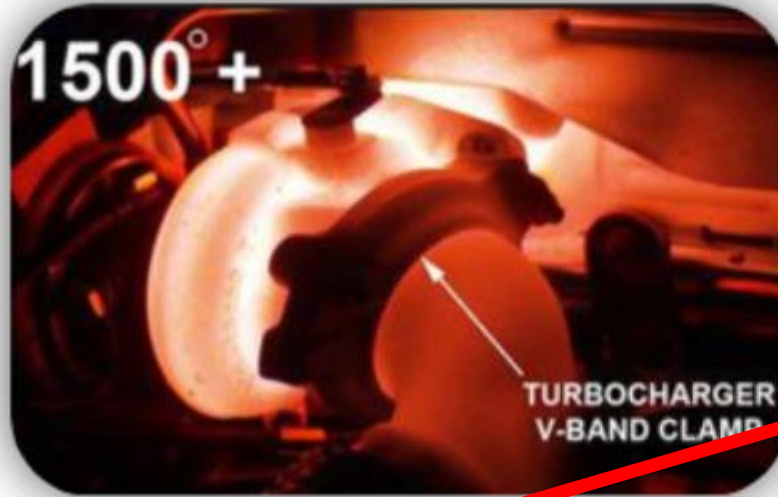
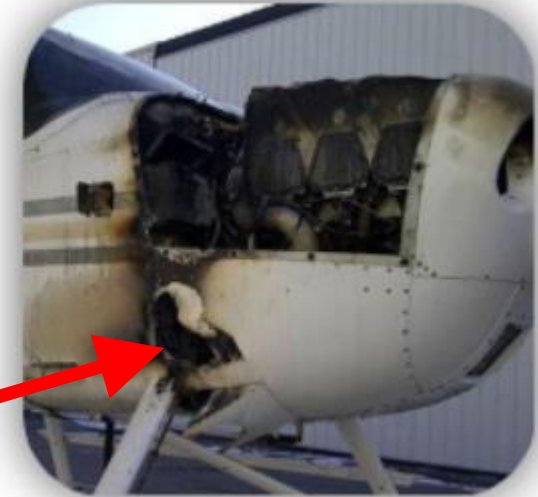
Special Emphasis Around Turbos

- Turbos get hot!

- V-band clamp failure

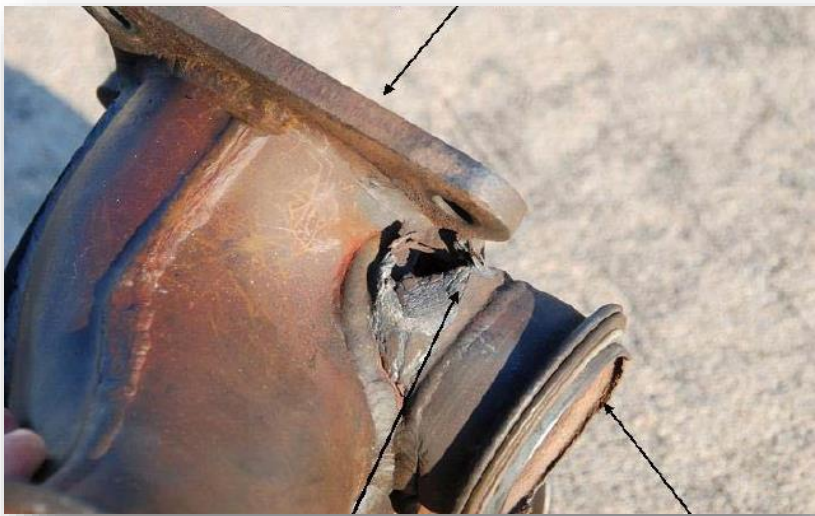
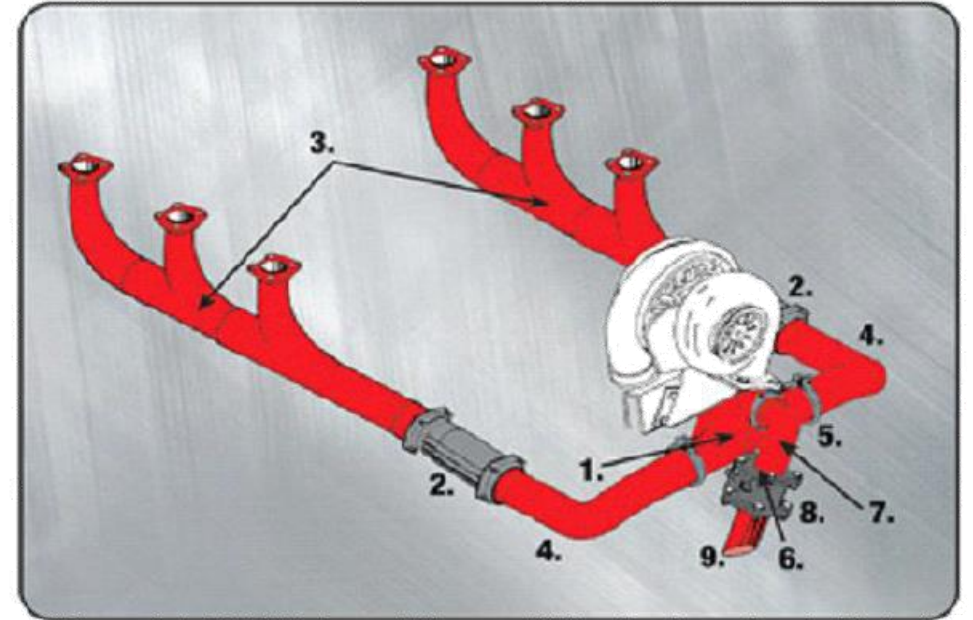
Exhaust Failures

- With exhaust temperatures reaching up to 1,300 °F, the clamp assembly could quickly be compromised if exhaust leaks
- “Blow-torch” effect

1. Wye duct, header assembly
2. Slip joint, ball joint
3. Riser
4. Elbow, manifold
5. Clamp
6. Waste-gate inlet
7. Wye to waste-gate elbow
8. Waste-gate valve
9. Waste-gate discharge

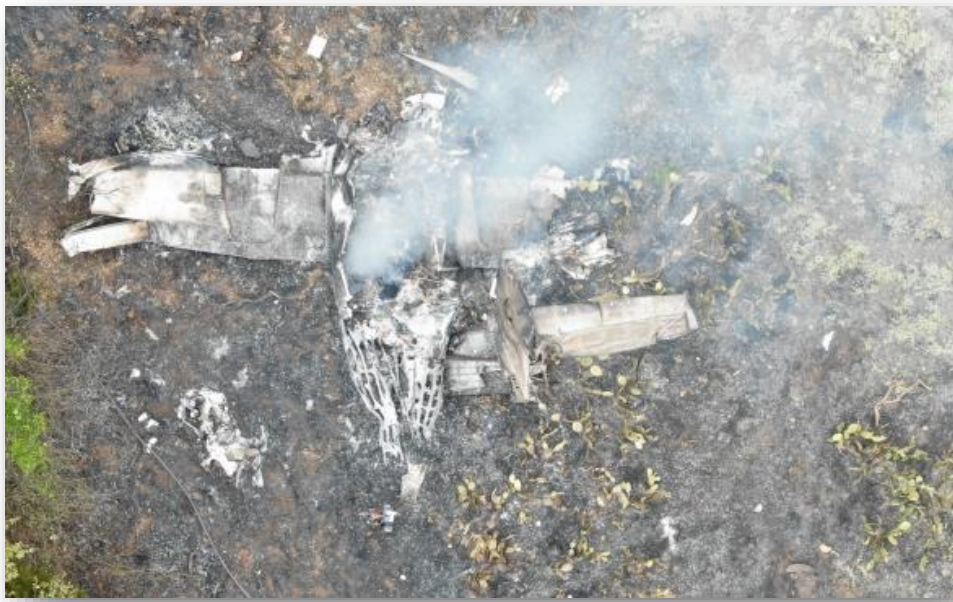
CEN17FA207 – Heat Exchanger

- **Post crash investigation**
- **Both exhausts unairworthy**
- **Thin metal, cracks, holes**

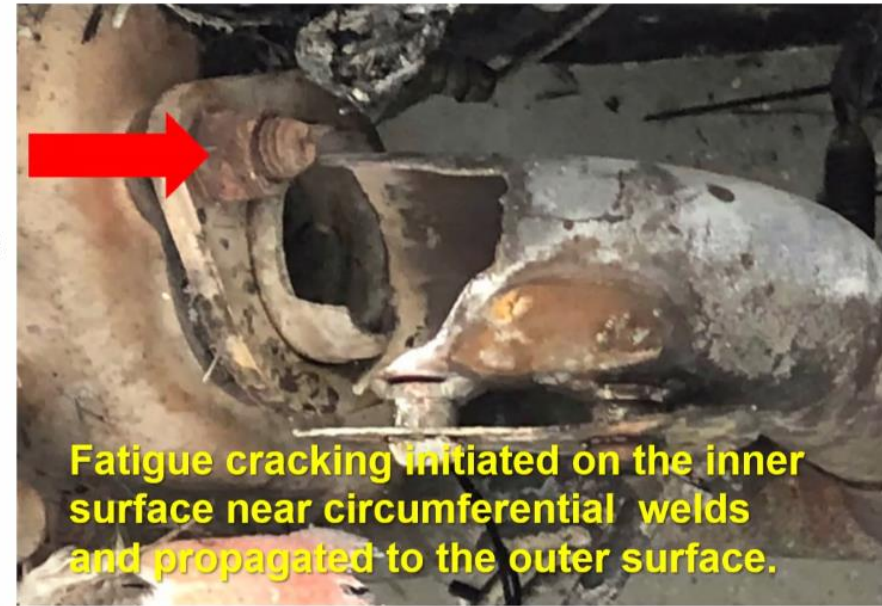
In addition to cracks, and holes, be sure to watch for loose/missing exhaust manifold Nuts and Studs

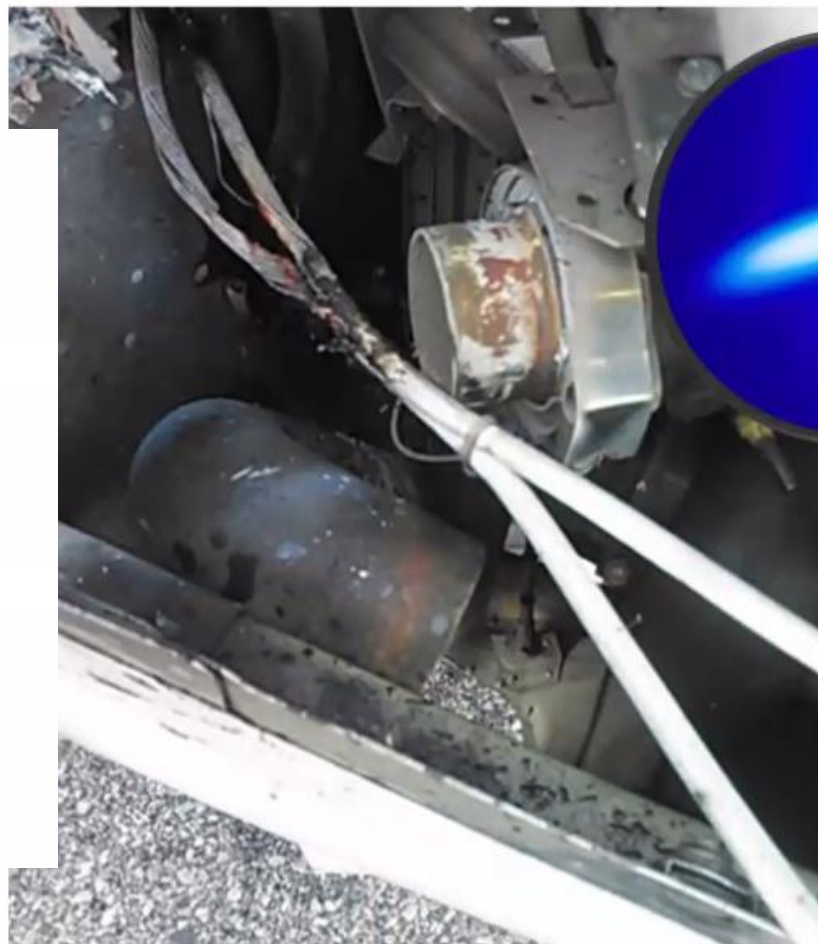
Photo 2 - Separated Tailpipe

Separated tailpipe

An in-flight fire during initial climb due to the separation of the engine's turbocharger wastegate overboard exhaust tailpipe. Contributing to the accident was the owner's decision to not comply with a service bulletin that addressed the tailpipe separation.

Cessna A Textron Company
<hr/>		
Service Bulletin		
December 6, 1999	SB99-71-06	
TITLE		
ENGINE EXHAUST TAILPIPE LANYARD INSTALLATION AND FUEL FLOW TRANSDUCER RELOCATION		
EFFECTIVITY		
<u>Model</u>	<u>Serial Numbers</u>	
T206H	T20608001 thru T20608112	
REASON		
A. For airplane serial numbers T20608001 thru T20608112: installation of an exhaust tailpipe lanyard is required to provide a safety link ensuring positive turbocharger exhaust tailpipe retention should the clamp become loose.

No lanyard was found on the airplane, and no record in the maintenance logbooks indicated that the service bulletin had been complied with. Issued 16 Years before the Accident.

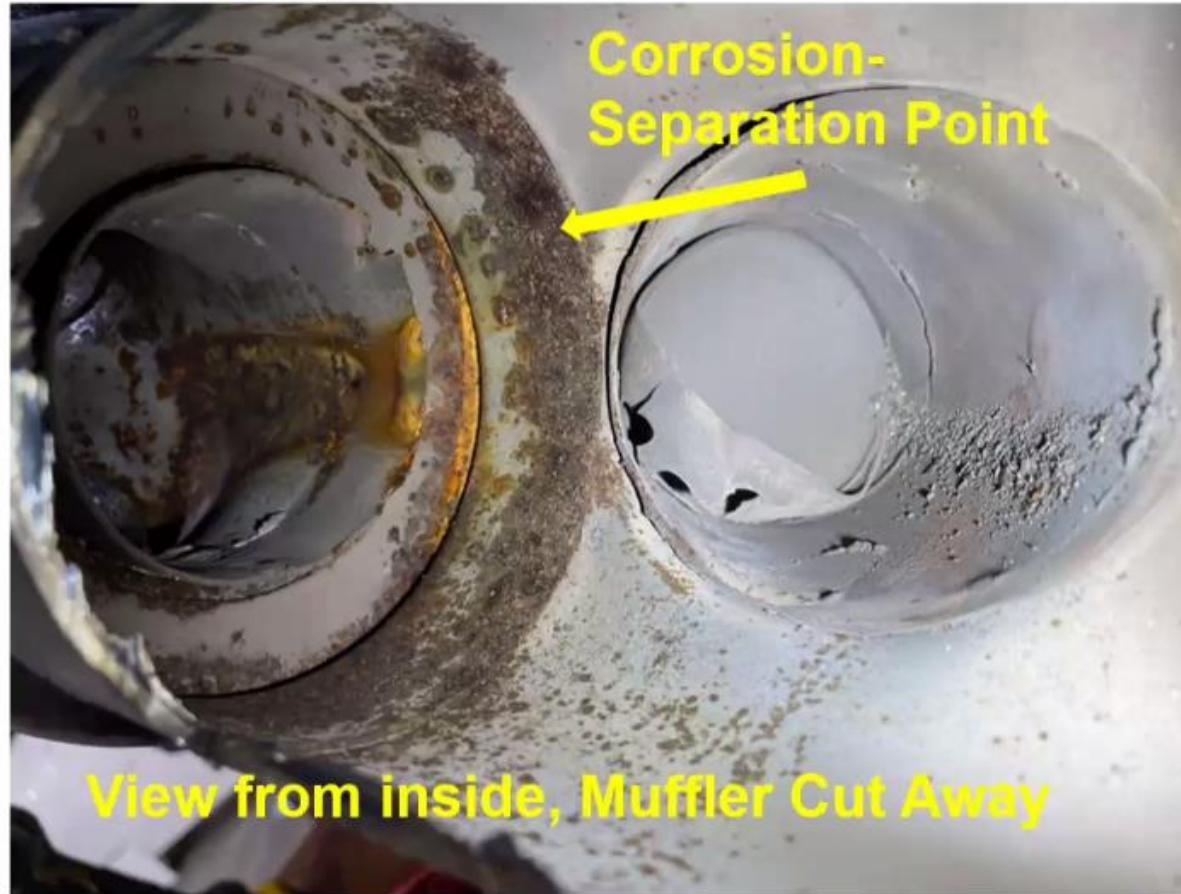
Photograph 11 - Inside muffler, flame tube lodged in tailpipe (Courtesy of NTSB)

The loss of engine power during go-around due to a failed muffler flame tube, which resulted in an exhaust blockage. Contributing to the accident was maintenance personnel's inadequate inspection of the exhaust system during the most recent maintenance.

Lodged in tail pipe

It is generally recommended that exhaust stacks, mufflers, tailpipes, etc., **be replaced with new or reconditioned components rather than repaired.** Welded repairs to exhaust systems are complicated by the difficulty of accurately identifying the base metal so that the proper repair materials can be selected.

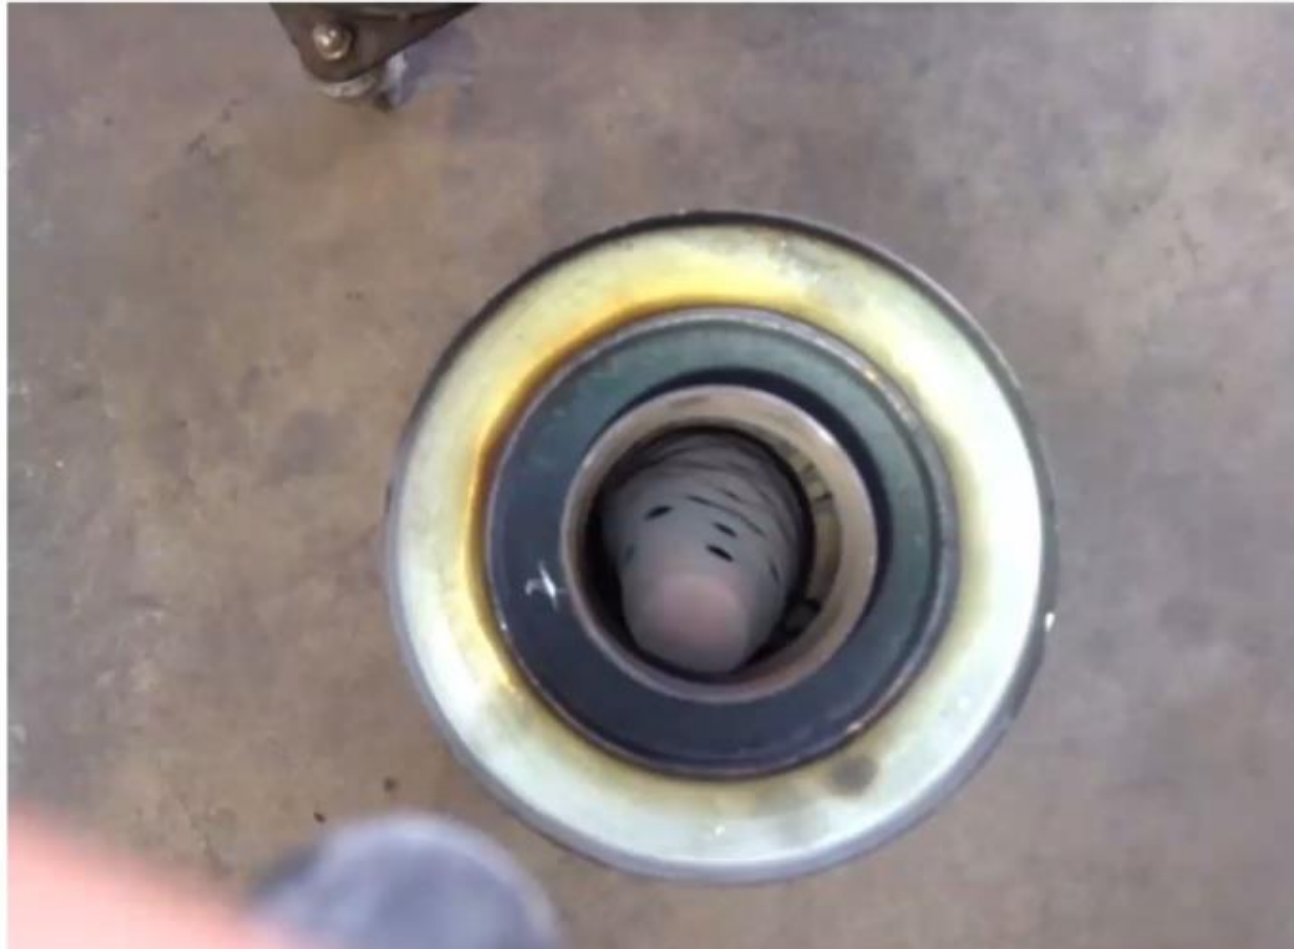
Beech Bonanza

Flame cone in the exhaust of a Beech Bonanza. Cone should be centered not sagging. It is easy to inspect for this fault by looking up the exhaust pipes.

Beech maintenance and overhaul documents revealed that the exhaust system should be overhauled or replaced every 800 hours or when the condition warrants replacement. The exhaust muffler and shroud should be inspected every 100 hours. The documentation states, “It is recommended that at each 100 hour and/or annual inspection, all exhaust muffler shrouds be removed and the muffler thoroughly inspected for cracks, leaks and (if applicable) deterioration of the internal tubes which could cause a decrease in engine power due to blockage of the exhaust.”

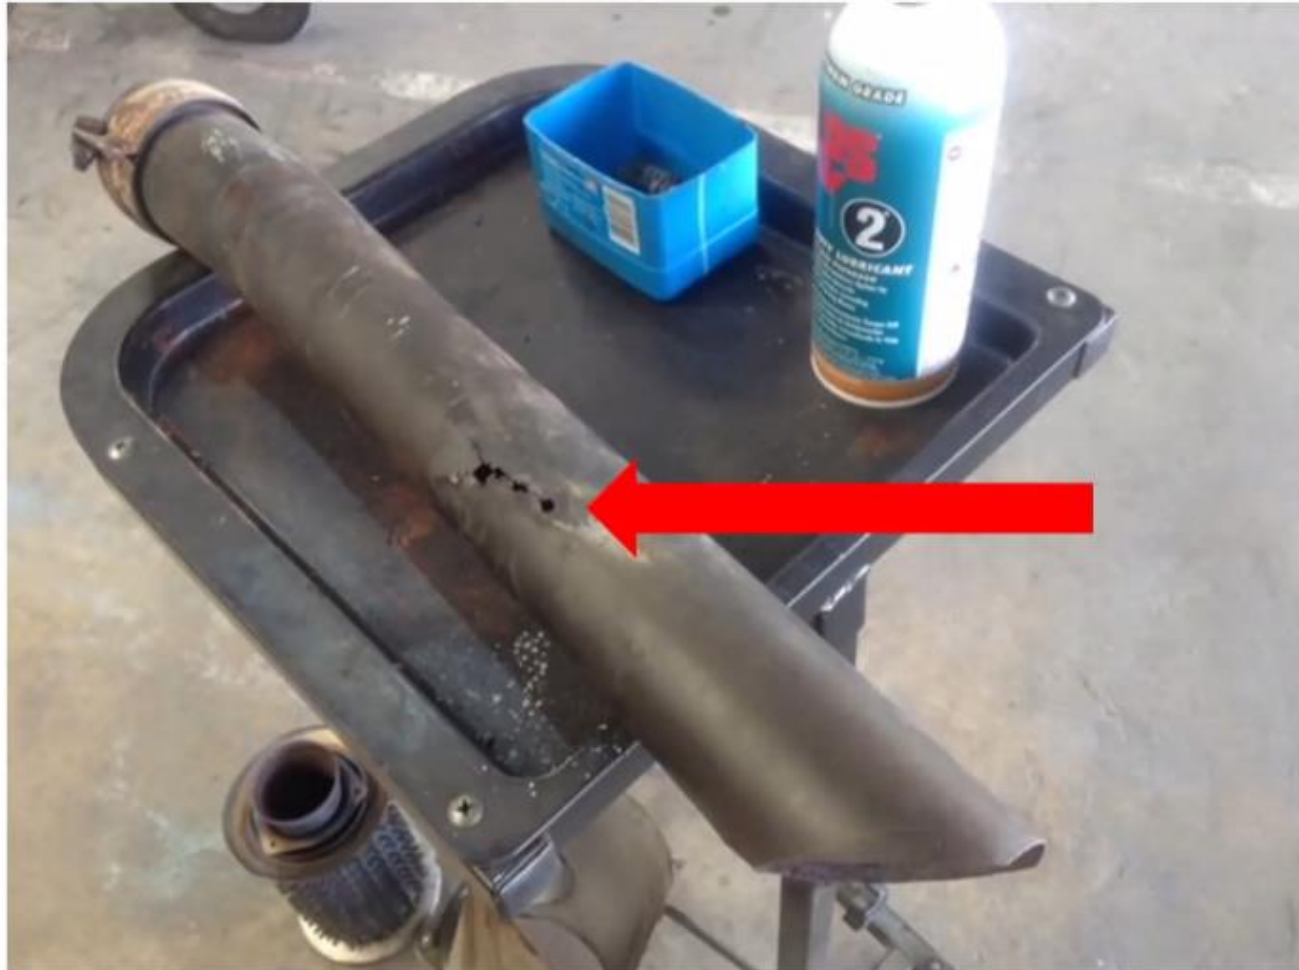
- **Downpipe rubbing on other structure**
