## Service Bulletin

SEB90-1  
Revision 3**TITLE**

MAIN LANDING GEAR PIVOT INSPECTION

**TITLE MAIN LANDING GEAR PIVOT AND ACTUATOR MODIFICATION**

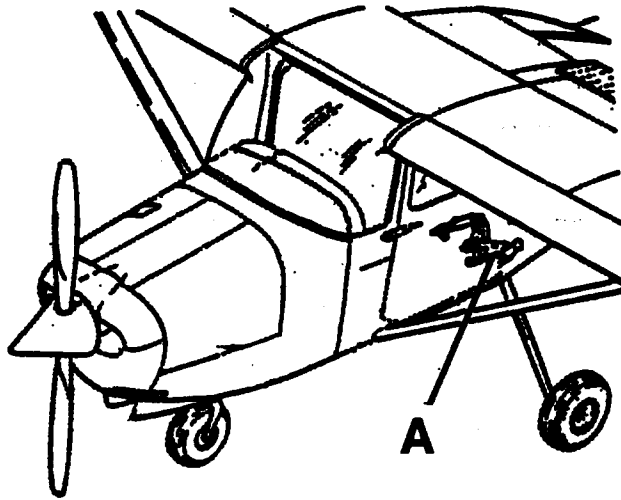
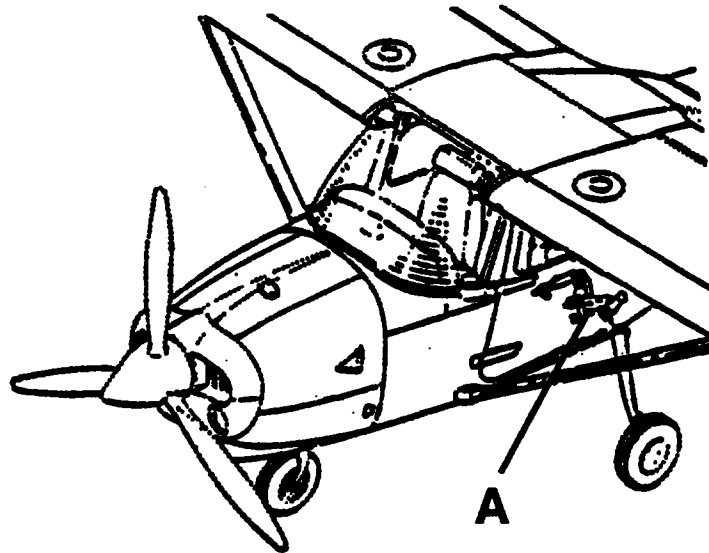
Figure 1. Main Landing Gear Pivot Assembly (Sheet 1 of 2)

To inspect the main landing gear pivot assemblies for cracks in the spline area. If a crack is detected, the pivot must be replaced.

5. Remove bushing (4) from pivot assembly shaft. Use a vise-grip type pliers or suitable tool to remove press fit bushing. Removal of bushing is required to inspect area (1A) between bushing (4) and spline (3). Discard bushing.
6. (Refer to Figure 1, Detail A, Sheet 2.) Perform a fluorescent penetrant inspection in areas (1A & 1B) on each pivot assembly as follows:
  - a. Using a magnifying glass inspect the radius of area (1A) for burrs that may be present as a result of the press fit bearing installation. If the inspection reveals the presence of a burr, continue with Step b. If the radius is free of burrs, continue with Step c.
