SUMMARY: This amendment supersedes Airworthiness Directive (AD) 75-23-08 R5, which currently requires repetitively inspecting and replacing or repairing the exhaust system on certain Cessna Aircraft Company (Cessna) 300 and 400 series airplanes. The requirements of this AD replace the inspections and replacements that are required by AD 75-23-08 R5 with inspections and replacements containing new simplified procedures for all 300 and 400 series airplanes (models affected by the current AD plus additional models). This AD also revises the inspection intervals and requires replacing certain unserviceable parts and removing the exhaust system for a detailed inspection. This AD is the result of numerous incidents and accidents relating to the exhaust systems on Cessna 300 and 400 series airplanes dating from the middle 1970's to the present, including six incidents since issuance of AD 75-23-08 R5 where exhaust problems were cited. The actions specified by this AD are intended to detect and correct cracks and corrosion in the exhaust system, which could result in exhaust system failure and a possible uncontrollable in-flight fire with pilot and/or passenger injury.

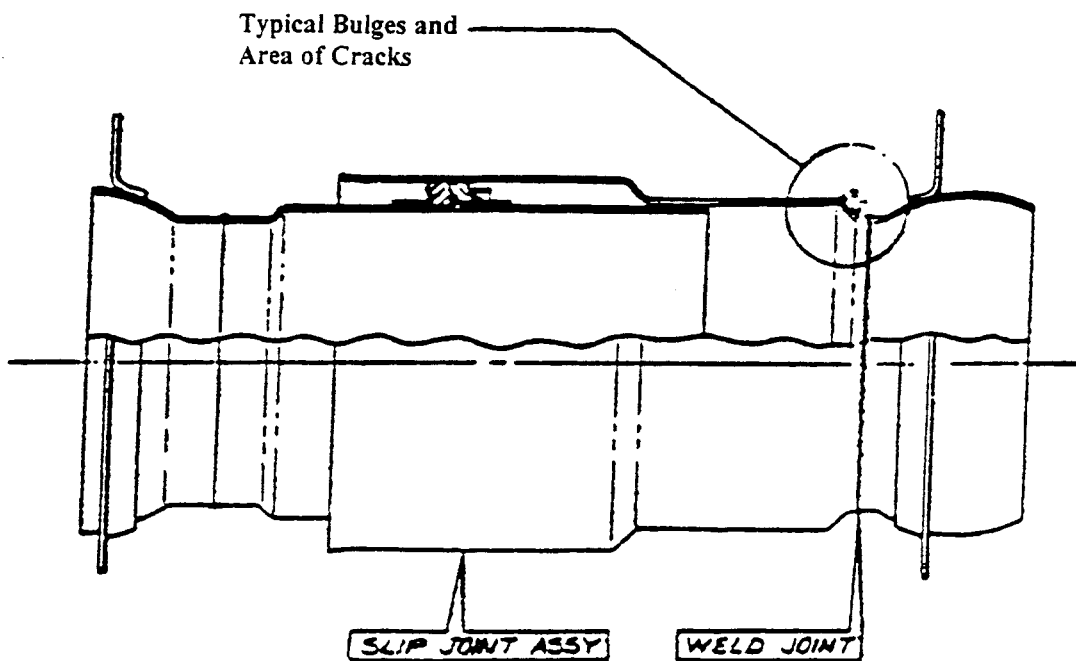
FIGURE 1 to the Appendix

(3) Visually inspect the exhaust joint springs for correct compression. If the joint is disturbed or if the springs are obviously loose or frozen, proceed with the following inspection (see Figure 1 of this Appendix).
