SERVICE BULLETIN

TITLE: WINGS - INSPECTION OF WING SPAR STRUCTURE

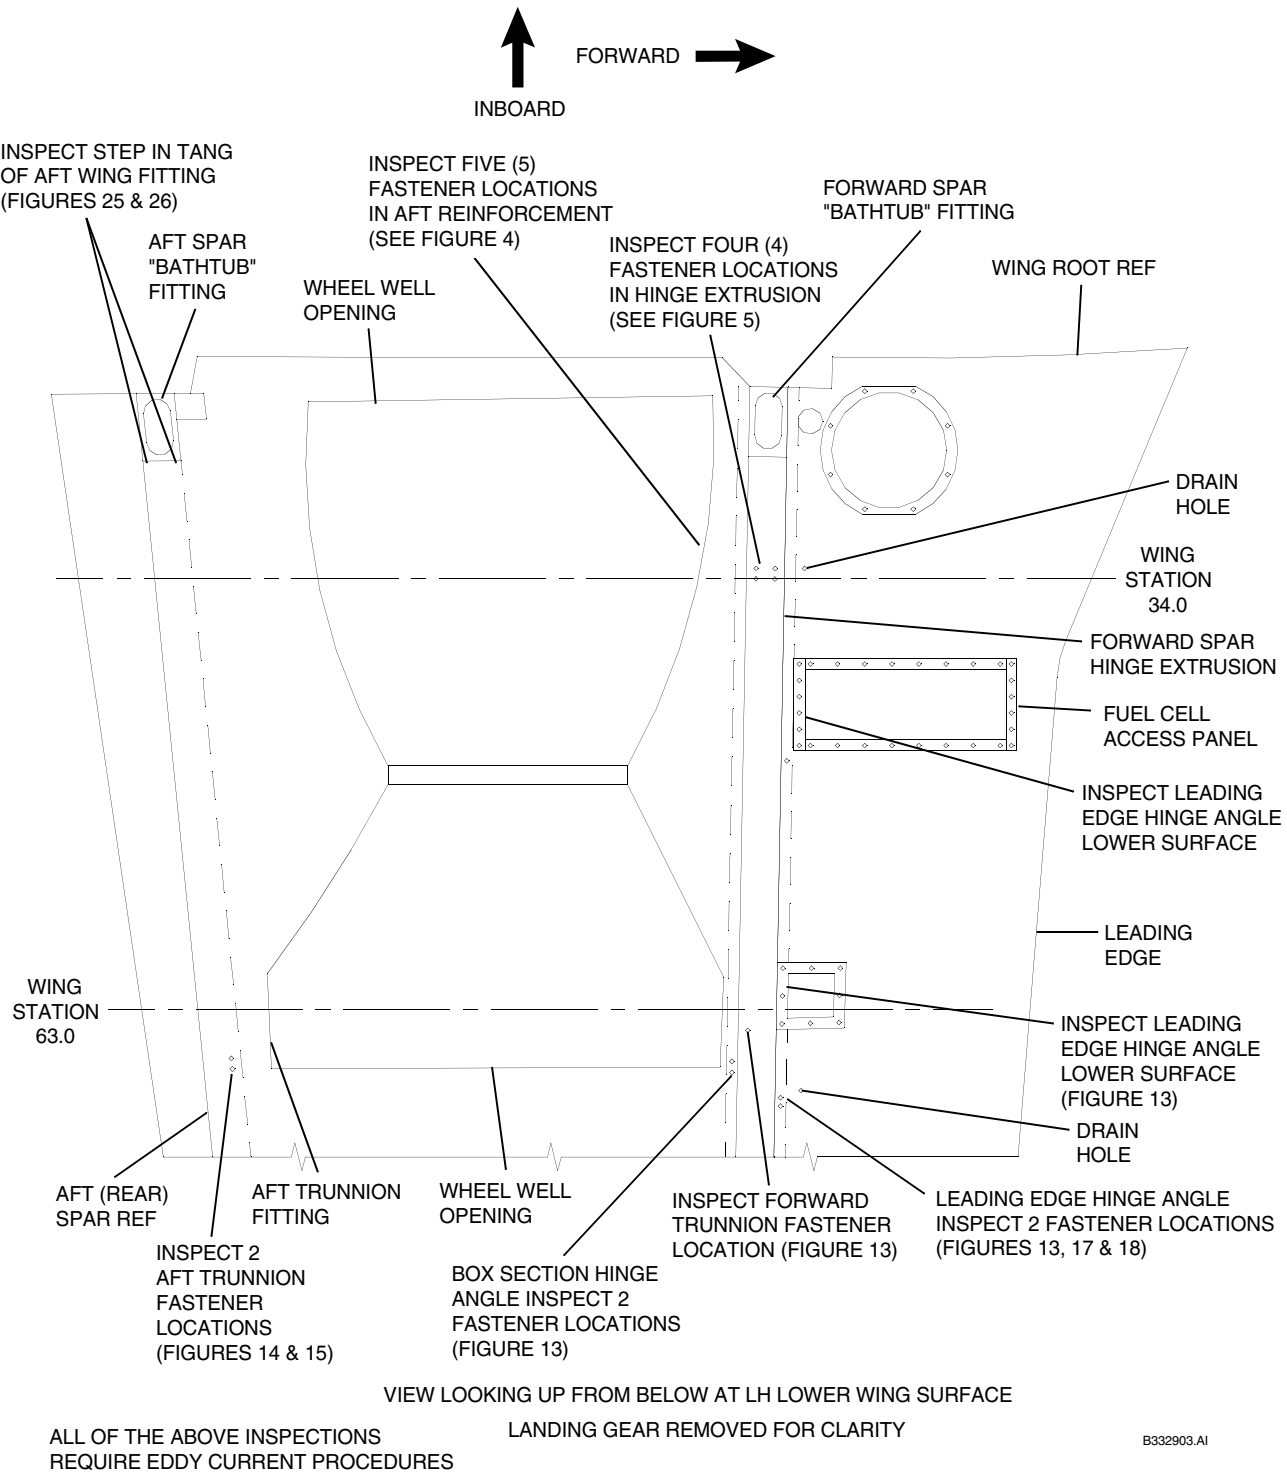
Figure 3

- (a) Locate the inboard forward (main) spar inspection area near W.S. 34.0 as shown in Figures 3, 4 5 and 6. This area consists of nine (9) fasteners in the lower forward spar.

Inspection Locations (LH Wing Shown)

- (f) If a crack is found during the Eddy Current Inspection of the forward spar as outlined in step (d) and step (e), the entire forward (main) spar assembly must be replaced **BEFORE FURTHER FLIGHT**.
- (9) Inspect three (3) MLG trunnion fitting fastener locations as follows:
- (a) Locate the MLG trunnion fittings in the wheel well area, reference Figures 3, 13, 14 and 15. The forward trunnion fitting is attached to the aft side of the forward (main) spar and the aft trunnion fitting is attached to the forward side of the aft (rear) spar near W.S. 63.0.

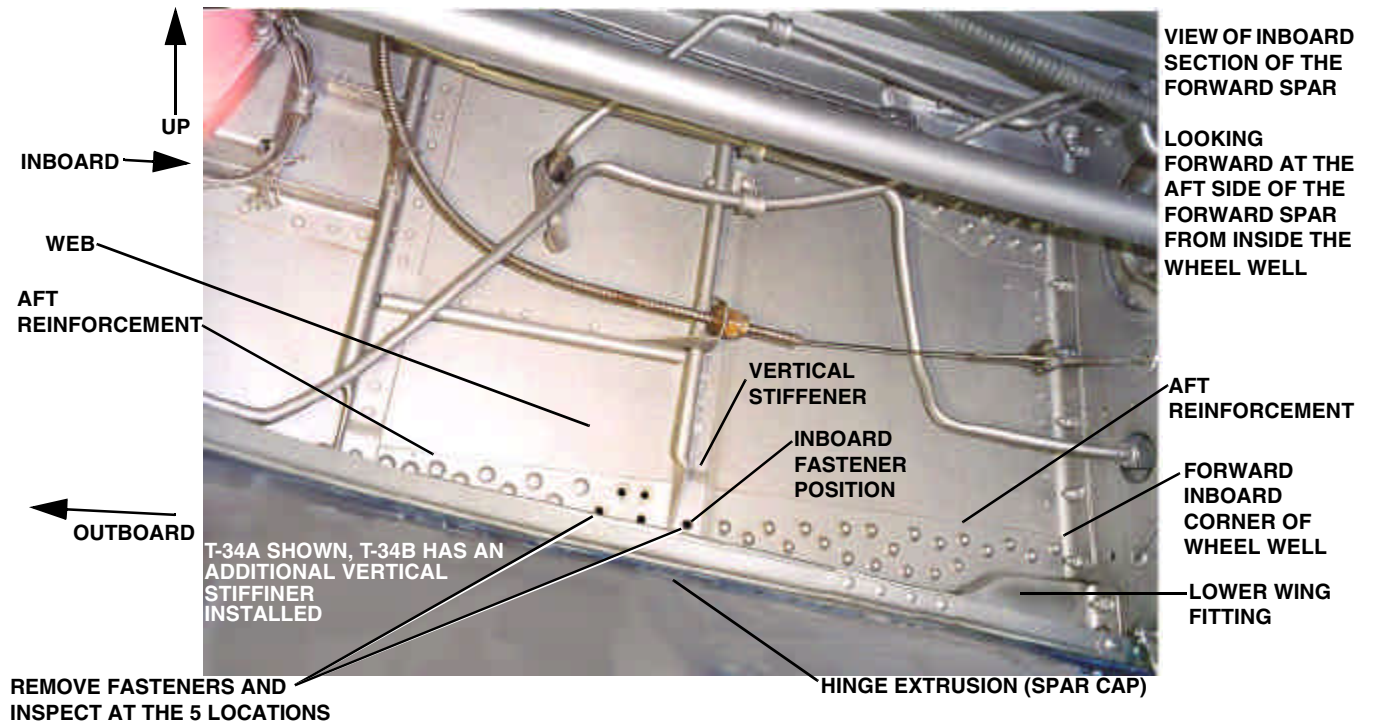
Inboard Forward Spar Inspection (Aft Side)
Figure 4

- Of the five (5) fasteners, the inboard fastener (reference the inboard fastener position in Figure 4) is installed in the vertical stiffener, aft reinforcement, spar web (both forward and aft elements), vertical spline of the lower forward wing fitting, forward "J" channel and forward reinforcement. Reference Detail A in Figure 2.
- The other fasteners in the group of five (5) are installed in the aft reinforcement, spar web, tapered spacer, aft "J" channel, forward "J" channel and forward reinforcement. Reference Figure 4 and Detail B in Figure 2.

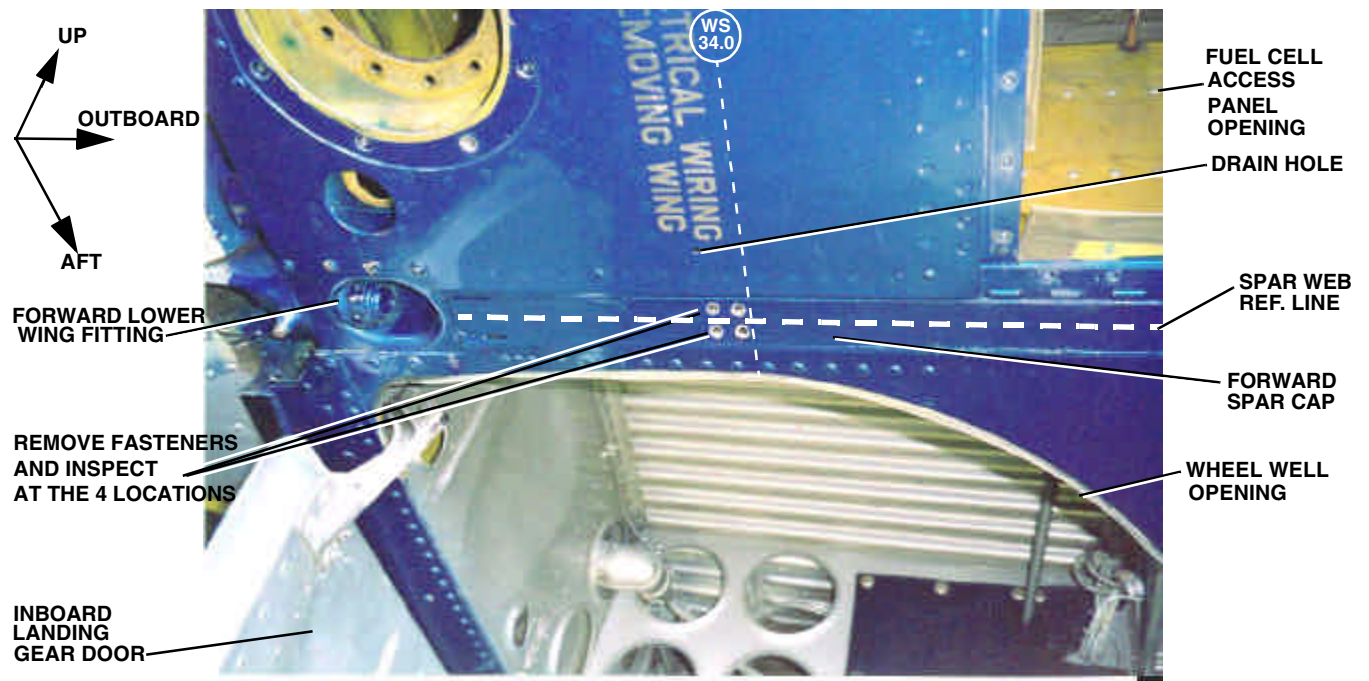
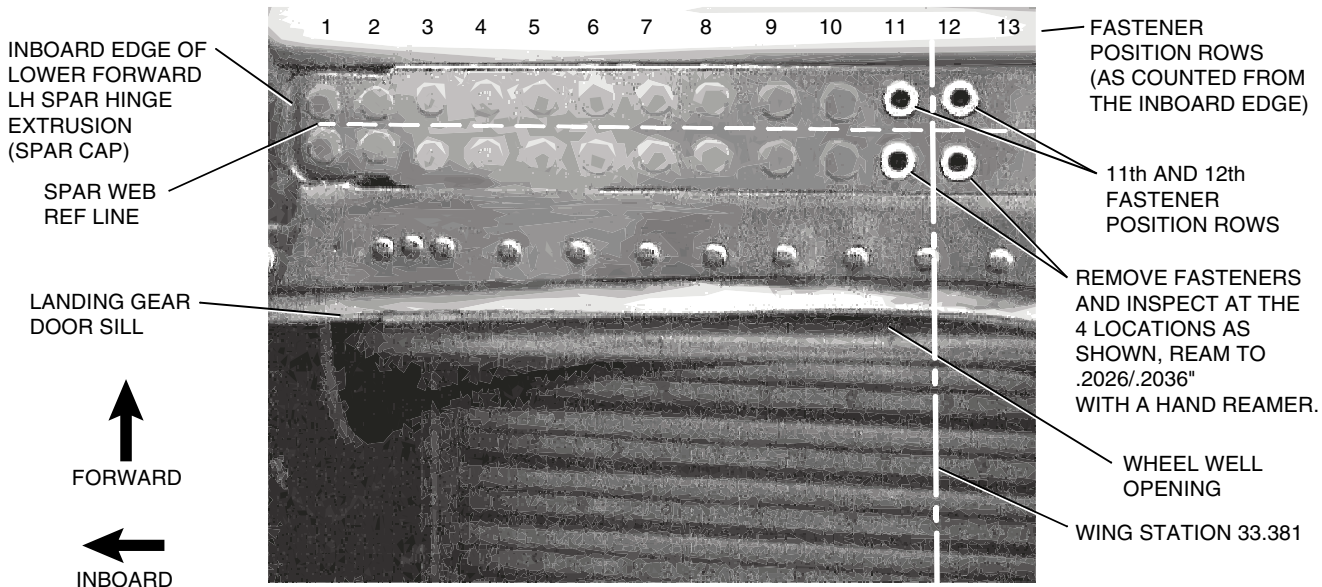
Inboard Forward Spar Inspection (Lower Side)
Figure 5

The other four (4) fasteners within the group of nine (9) fasteners (reference Figures 5 and 6) are installed through the lower forward spar hinge extrusion (spar cap), filler strip, tang on the outboard end of the wing fitting and horizontal flange of their respective forward "J" channel or aft "J" channel near W.S. 34.0. The fastener shanks are oriented vertically (2 are located on the forward side of the spar web, the other 2 are aft of the spar web) and are installed at the outboard end of the lower forward wing fitting. Reference Detail B in Figure 2.

- (ii) Access the other four (4) fasteners from below the wing surface. Locate the forward (main) lower spar hinge extrusion (spar cap) on the lower side of the wing. The lower spar hinge extrusion has a series of fastener rows with 2 fasteners installed in each row. The four (4) fasteners to be removed are located in the lower spar hinge extrusion and are in the 11th and 12th fastener rows in the hinge extrusion as counted from the inboard edge of the lower spar hinge extrusion (reference Figure 5 and Figure 6). The fastener shanks are oriented vertically and are installed immediately aft of a drain hole in the lower side of the leading edge. These fasteners are installed through the lower spar hinge extrusion (spar cap), filler strip, lower forward wing fitting tang and respective forward or aft "J" channel. Remove the fastener heads and push the shanks up through the lower spar structure.

- (ii) Ream the group of four (4) fastener holes in the forward spar lower hinge extrusion (spar cap) (reference Figures 5 and 6) that were removed in step (8) (b) (ii), to the first oversize of .2026/.2036 inch diameter for NAS1703 bolts. Protect both the forward and aft side of the forward spar by placing (.005" or .010" thick) brass or stainless steel shim stock sheet against the forward and aft reinforcements before reaming. If a smoother hole is required, it is permissible ream to the second standard oversize of .2183/.2193 inch diameter for NAS1603 bolts.

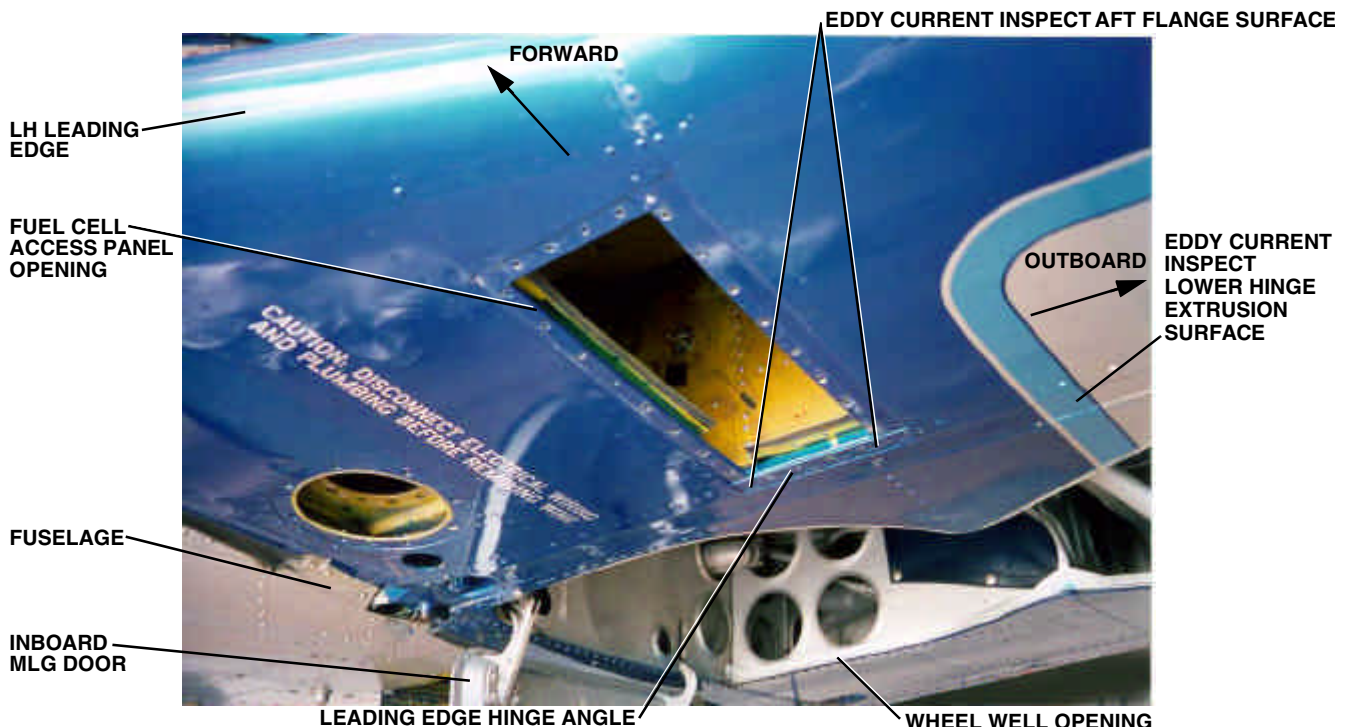
Leading Edge Hinge Angle and Fuel Cell Access Panel
Figure 17

- (v) Note any crack indications.
- (f) Perform an Eddy Current NDI inspection of two (2) of the leading edge hinge angle surfaces. The first area to be scanned is located on the leading edge lower hinge angle adjacent to the small square access panel opening (fuel vent access door/trunnion access door) near the MLG trunnion, reference the aft flange in Figure 14. The second area to be scanned is adjacent to the aft side of the fuel cell access panel opening (reference aft flange surface in Figure 17).

- (v) Visually inspect the lower wing skin adjacent to the area Eddy Current Inspected in step (10) (f) (iv). Look closely at the area next to the fuel cell access panel aft flange surface for cracks or distortions in the paint. Reference Figure 17. If distortions are found, remove the paint for a closer inspection. Visually check for cracks in the lower wing skin and leading edge lower hinge angle.

- (g) If a crack is found during the Eddy Current Inspection in any of the fastener holes inspected in either step (10) (d), the hinge radius inspected in step (10) (e) or the lower skin and hinge angle surface inspections in step (10) (f) the corresponding hinge angle assembly(ies) must be replaced **BEFORE FURTHER FLIGHT**.

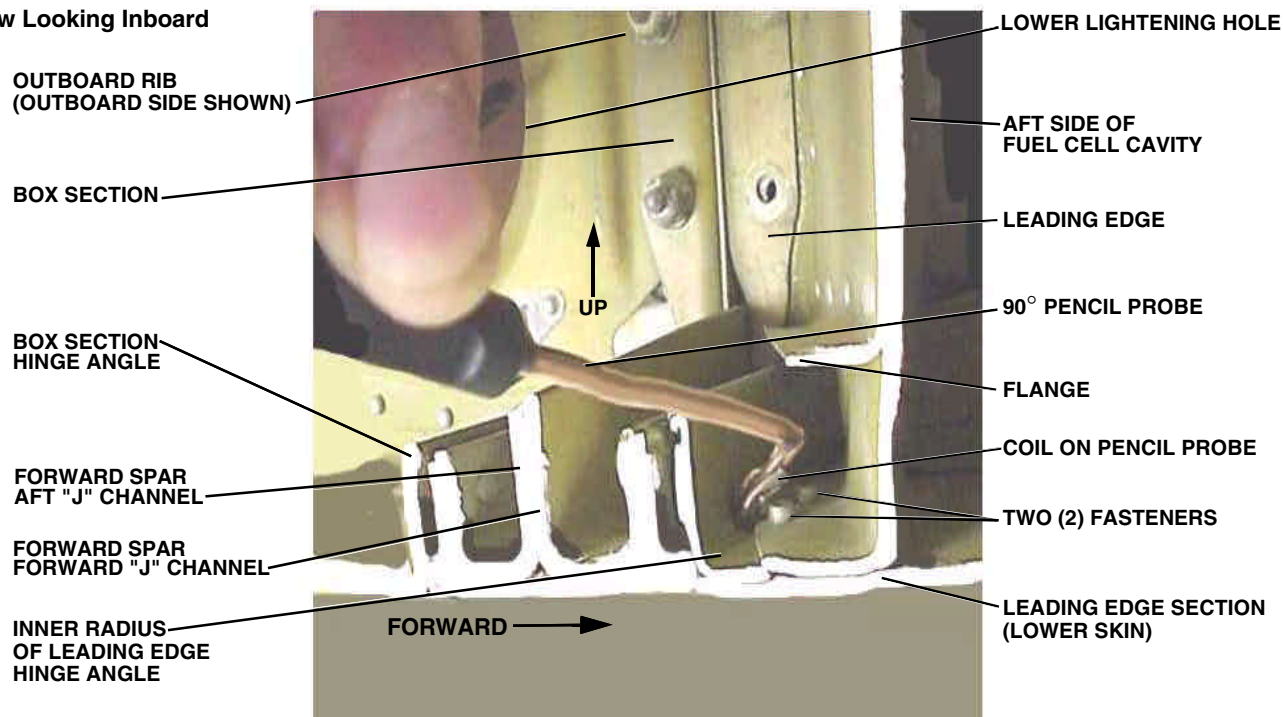
Figure 19

(ii) Scan the holes and note any crack indications. Verify all indications with a standard bolt hole probe set to the precise depth of the hinge angle.

Scanning the Leading Edge Lower Hinge Angle (RH Wing Shown)
